Access Compliance Report

Public Rights-of-Way

(Curb Ramps)

Intersection ID: 8276	Main Street: BROOKSHIRE_BV	Cross Street: N LINWOOD_AV	Location: NE
ADA ID: 8336551CFBE7	Ramp Type: Para	Initial Pass/Fail: Fail	Overall Compliance: No
			Severity Score: 26.25

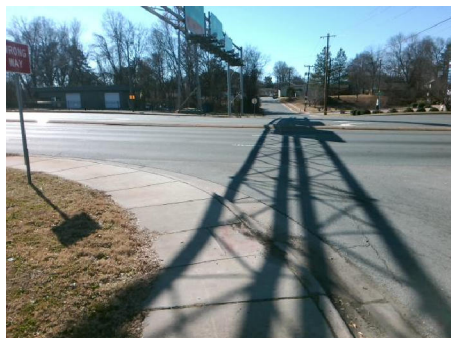
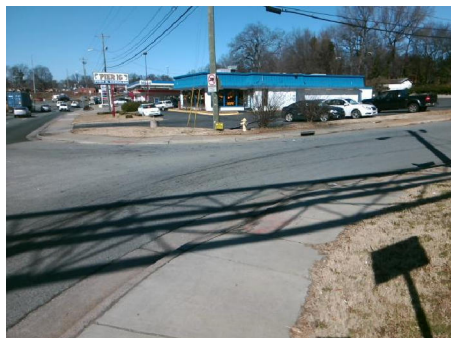
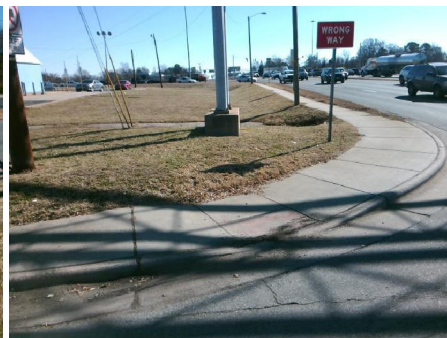
R304.3.2, R304.5.3

Compliance	Description	Data	Compliance	Description	Data
N/A	Ramp Length LT (in)	34.5	N/A	Ramp Length RT (in)	43.0
Yes	Ramp Width LT (in)	64.0	Yes	Ramp Width RT (in)	69.0
No	Ramp Slope LT (%)	12.4	No	Ramp Slope RT (%)	10.0
Yes	Ramp XSlope LT (%)	1.0	No	Ramp XSlope RT (%)	2.6
N/A	Landing Length (in)	N/A	N/A	DWS Provided?	N/A
N/A	Landing Width (in)	N/A	N/A	DWS Contrast?	N/A
N/A	Landing Slope (%)	N/A	N/A	DWS Length (in)	N/A
N/A	Landing X Slope (%)	N/A	N/A	DWS Full Width?	N/A
N/A	Landing Curb? (Y/N)	N/A	N/A	DWS Offset (in)	N/A
N/A	Shared Landing?	N/A			
N/A	Gutter Ponding?	N/A	N/A	Gutter Slope (%)	N/A
N/A	Gutter Lip Ht (in)	N/A	N/A	Gutter X Slope (%)	N/A
N/A	Painted X Walk1?	No	N/A	Painted X Walk2?	N/A
	X Walk 1 Direction	To NW		X Walk 2 Direction	N/A
N/A	X Walk 1 Width (in)	N/A	N/A	X Walk 2 Width (in)	N/A
	X Walk 1 Slope (%)	0.0		X Walk 2 Slope (%)	N/A
	X Walk 1 X Slope (%)	0.8		X Walk 2 X Slope (%)	N/A
N/A	Ramp inside XWalk1?	N/A	N/A	Ramp inside XWalk2?	N/A

Road Slope (%)	N/A	N/A	Clear Space?	N/A
	Road X Slope (%)	N/A	N/A	Clear Space to XWalk (in)	N/A
N/A	Any Obstructions?	N/A	N/A	Storm Grate/Utility Hazard?	N/A
	Obstruction Type			Storm Grate/Utility Type	
		N/A			N/A
			Yes	Surface Condition? (G/P)	Good
			N/A	Curb Slope (%)	0.4

Remove & Replace Entire Ramp.

Total Cost: \$ 1600.00
