# Access Compliance Report

## Public Rights-of-Way (Curb Ramps)

| Intersection ID: 11231 | Main Street: W_4TH_ST_EXT | Cross Street: WALNUT_AV | Location: | N |
| ADA ID: 833FDF6C6DD4 | Ramp Type: Directional1 | Initial Pass/Fail: Pass | Overall Compliance: No | Severity Score: 0 |

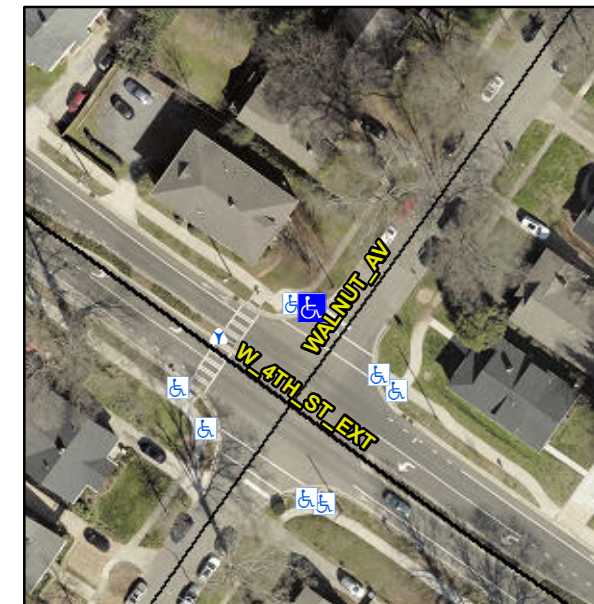
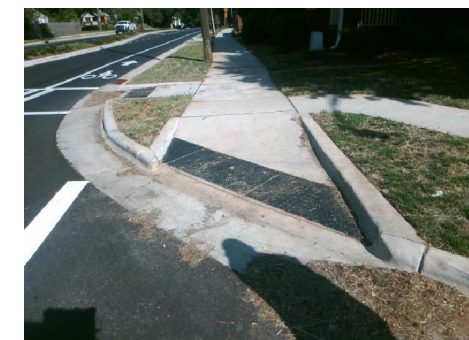
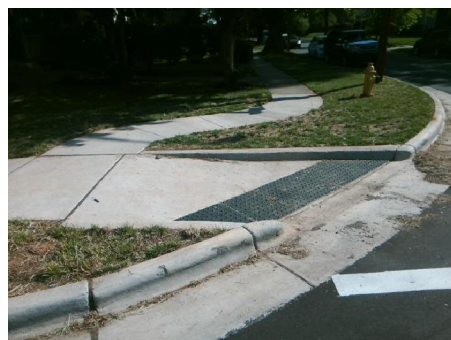
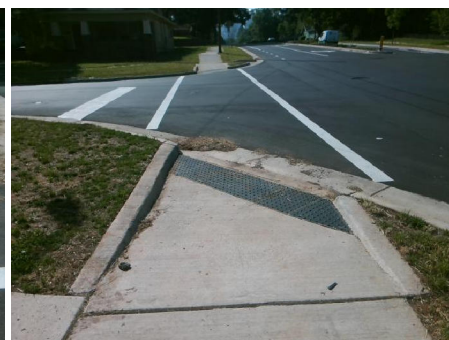
**R304.2.1, R304.2.2-Perp, R304.3.2-Para, R304.5.2, R305.2**

| Compliance | Description | Data | Compliance | Description | Data |
|---|---|---|---|---|---|
| N/A | Ramp Length (in) | 65.0 | No | Grade Break? | No |
| No | Landing Length (in) | 45.0 | Yes | DWS Provided? | Yes |
| No | Landing Slope (%) | 2.4 | Yes | DWS Length (in) | 24.0 |

**Remove & Replace Entire Ramp.**

Total Cost: \$ 1600.00
