Access Compliance Report

Public Rights-of-Way (Curb Ramps)

Intersection ID: 16680	Main Street: NORTH_FALLS_DR	Cross Street: WATER_RIDGE_PY	Location: SW
ADA ID: 83427DF1E8C1	Ramp Type: PerpDiag	Initial Pass/Fail: Fail	Overall Compliance: No
		Severity Score: 22.5

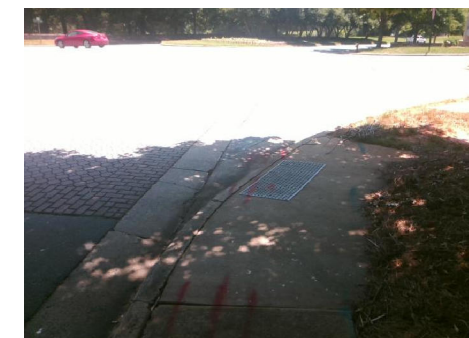
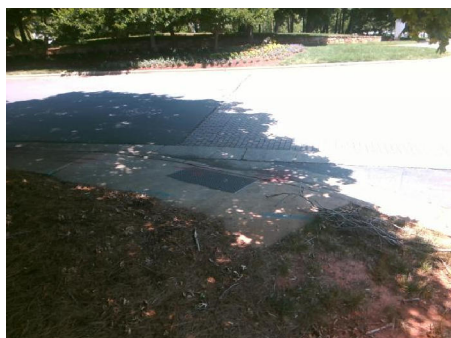
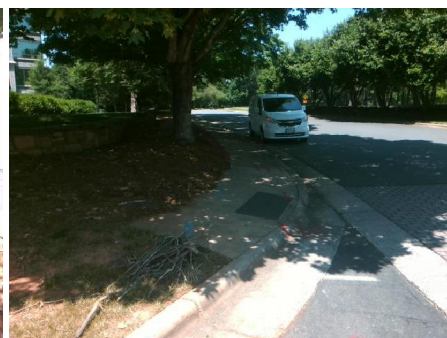
Not Found, R304.5.1, R304.2.2, R304.5.3

Compliance	Description	Data	Compliance	Description	Data
N/A	Ramp Length (in)	64.0	No	Ramp Slope (%)	10.1
No	Ramp Width (in)	45.0	No	Ramp XSlope (%)	4.4
N/A	Flare Type LT	N/A	N/A	Flare Type RT	N/A
N/A	Flare Slope LT (%)	N/A	N/A	Flare Slope RT (%)	N/A
N/A	Flare Traversable LT?	N/A	N/A	Flare Traversable RT?	N/A
N/A	Landing Length (in)	N/A	N/A	DWS Provided?	N/A
N/A	Landing Width (in)	N/A	N/A	DWS Contrast?	N/A
N/A	Landing Slope (%)	N/A	N/A	DWS Length (in)	N/A
N/A	Landing X Slope (%)	N/A	N/A	DWS Full Width?	N/A
N/A	Landing Curb? (Y/N)	N/A	N/A	DWS Offset (in)	N/A
N/A	Shared Landing?	N/A			
N/A	Gutter Ponding?	N/A	N/A	Gutter Slope (%)	N/A
N/A	Gutter Lip Ht (in)	N/A	N/A	Gutter X Slope (%)	N/A
N/A	Painted X Walk1?	No	N/A	Painted X Walk2?	No
	X Walk 1 Direction	To E		X Walk 2 Direction	To N
N/A	X Walk 1 Width (in)	N/A	N/A	X Walk 2 Width (in)	N/A
	X Walk 1 Slope (%)	4.5		X Walk 2 Slope (%)	2.6
	X Walk 1 X Slope (%)	3.0		X Walk 2 X Slope (%)	4.4

N/A	Ramp inside XWalk1?	N/A	N/A	Ramp inside XWalk2?	N/A
	Road Slope (%)	6.2	N/A	Clear Space?	N/A
	Road X Slope (%)	2.2	N/A	Clear Space to XWalk (in)	N/A
N/A	Any Obstructions?	N/A	N/A	Storm Grate/Utility Hazard?	N/A
	Obstruction Type			Storm Grate/Utility Type	
		N/A			N/A
			Yes	Surface Condition? (G/P)	Good

Remove & Replace Curb Ramp With Two New Directional Ramps or Equivalent.
