## **Access Compliance Report Public Rights-of-Way** (Curb Ramps)

Intersection ID: 9052 Main Street: JEFFERSON DAVIS ST Cross Street: MORETZ\_AV Location: ADA ID: 8347952F435A Ramp Type: Para Initial Pass/Fail: Fail **Overall Compliance: No** Severity Score: 18.75

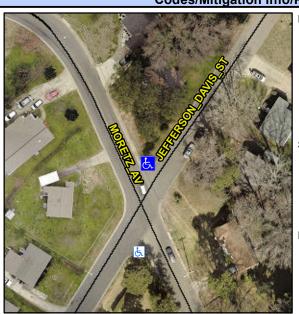
**JEFFERSON DAVIS ST** Street 1 Name Stop Condition-Street 1 None Street 2 Name N/A Stop Condition-Street 2 N/A Possible Solutions: Remove & Replace Entire Ramp. Surveyor Notes: NO RT SW, RT RP < 5% PROW/ADA: R304.5.1, R304.5.3

Field Measurements/Component Compliance					
Compliance Description		Data	Comp	liance Description	Data
N/A	Ramp Length LT (in)	31.0	N/A	Ramp Length RT (in)	53.0
No	Ramp Width LT (in)	39.0	No	Ramp Width RT (in)	33.0
Yes	Ramp Slope LT (%)	5.0	Yes	Ramp Slope RT (%)	1.0
Yes	Ramp XSlope LT (%)	1.9	No	Ramp XSlope RT (%)	3.4
N/A	Landing Length (in)	N/A	N/A	DWS Provided?	N/A
N/A	Landing Width (in)	N/A	N/A	DWS Contrast?	N/A
N/A	Landing Slope (%)	N/A	N/A	DWS Length (in)	N/A
N/A	Landing X Slope (%)	N/A	N/A	DWS Full Width?	N/A
N/A	Landing Curb? (Y/N)	N/A	N/A	DWS Offset (in)	N/A
N/A	Shared Landing?	N/A			
N/A	Gutter Ponding?	N/A	N/A	Gutter Slope (%)	N/A
N/A	Gutter Lip Ht (in)	0.5	N/A	Gutter X Slope (%)	N/A
N/A	Painted X Walk1?	No	N/A	Painted X Walk2?	N/A
	X Walk 1 Direction	To SE		X Walk 2 Direction	N/A
N/A	X Walk 1 Width (in)	N/A	N/A	X Walk 2 Width (in)	N/A
	X Walk 1 Slope (%)	3.9		X Walk 2 Slope (%)	N/A
	X Walk 1 X Slope (%)	2.0		X Walk 2 X Slope (%)	N/A

N/A	Ramp inside XWalk1?	N/A	N/A	Ramp inside XWalk2?	N/A
	Road Slope (%)	N/A	N/A	Clear Space?	N/A
	Road X Slope (%)	N/A	N/A	Clear Space to XWalk (in)	N/A
N/A	Any Obstructions?	N/A	N/A	Storm Grate/Utility Hazard?	N/A
	Obstruction Type			Storm Grate/Utility Type	
		N/A			N/A
			Yes	Surface Condition? (G/P)	Good
			N/A	Curb Slope (%)	N/A
