Access Compliance Report

Public Rights-of-Way

(Curb Ramps)

Intersection ID: 10862	Main Street: N_GRAHAM_ST	Cross Street: DALTON_AV	Location: NE
ADA ID: 834ACB3BB6ED	Ramp Type: PerpDiag	Initial Pass/Fail: Fail	Overall Compliance: No
Severity Score: 21.25			
Codes/Mitigation Info/Possible Solution		Field Measurements/Component Compliance

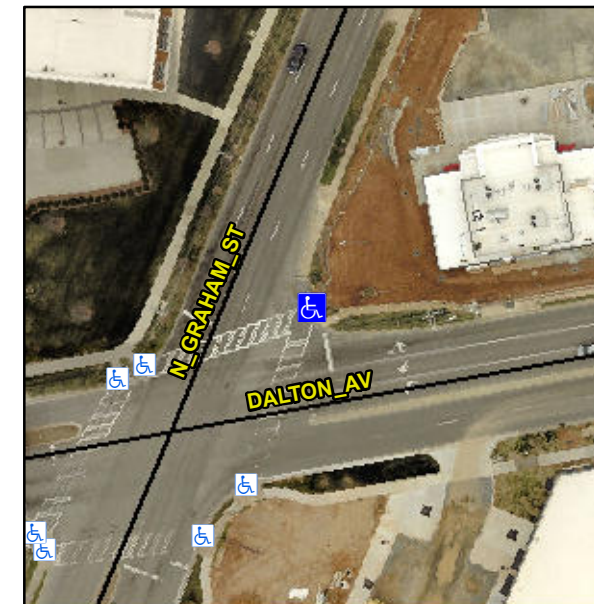
Not Found, R304.5.1, R304.2.2

Compliance	Description	Data	Compliance	Description	Data
N/A	Ramp Length (in)	59.5	No	Ramp Slope (%)	9.4
No	Ramp Width (in)	39.0	Yes	Ramp XSlope (%)	1.5
N/A	Flare Type LT	N/A	N/A	Flare Type RT	N/A
N/A	Flare Slope LT (%)	N/A	N/A	Flare Slope RT (%)	N/A
N/A	Flare Traversable LT?	N/A	N/A	Flare Traversable RT?	N/A
N/A	Landing Length (in)	N/A	N/A	DWS Provided?	N/A
N/A	Landing Width (in)	N/A	N/A	DWS Contrast?	N/A
N/A	Landing Slope (%)	N/A	N/A	DWS Length (in)	N/A
N/A	Landing X Slope (%)	N/A	N/A	DWS Full Width?	N/A
N/A	Landing Curb? (Y/N)	N/A	N/A	DWS Offset (in)	N/A
N/A	Shared Landing?	N/A			
N/A	Gutter Ponding?	N/A	N/A	Gutter Slope (%)	N/A
N/A	Gutter Lip Ht (in)	N/A	N/A	Gutter X Slope (%)	N/A
N/A	Painted X Walk1?	Yes	N/A	Painted X Walk2?	Yes
	X Walk 1 Direction	To SW		X Walk 2 Direction	To SE
N/A	X Walk 1 Width (in)	140.0	N/A	X Walk 2 Width (in)	109.5
	X Walk 1 Slope (%)	5.7		X Walk 2 Slope (%)	2.7
	X Walk 1 X Slope (%)	1.4		X Walk 2 X Slope (%)	4.3

N/A	Ramp inside XWalk1?	Yes	N/A	Ramp inside XWalk2?	Yes
	Road Slope (%)	0.5	N/A	Clear Space?	N/A
	Road X Slope (%)	4.3	N/A	Clear Space to XWalk (in)	N/A
N/A	Any Obstructions?	N/A	N/A	Storm Grate/Utility Hazard?	N/A
	Obstruction Type			Storm Grate/Utility Type	
		N/A			N/A
		Yes		Surface Condition? (G/P)	Good

Possible Solutions:

Remove & Replace Curb Ramp With Two New Directional Ramps or Equivalent.
