Access Compliance Report

Public Rights-of-Way

(Curb Ramps)

Intersection ID: 45156	Main Street: MACVEAN_LN	Cross Street: REID_MEADOWS_DR	Location: SE
ADA ID: 836191E6CC9A	Ramp Type: PerpDiag	Initial Pass/Fail: Fail	Overall Compliance: No
		Severity Score: 18.75

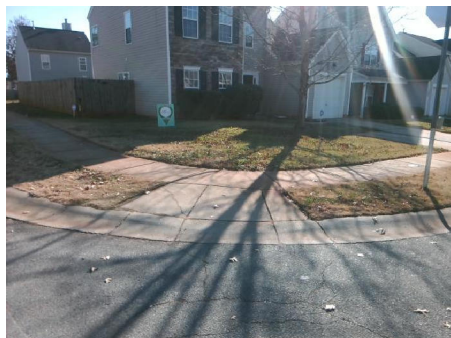
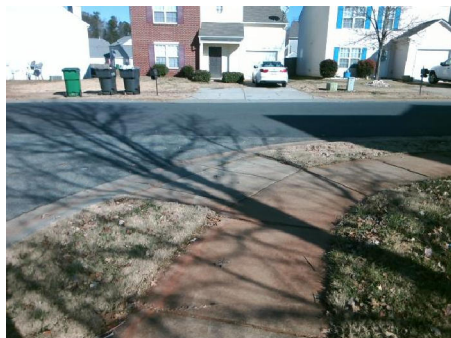
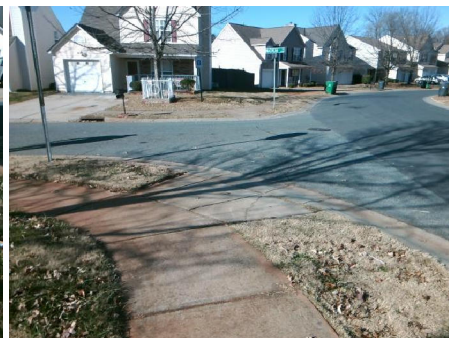
Possible Solutions:		Compliance	Description	Data	Compliance	Description	Data
	Remove & Replace Curb Ramp With Two New Directional Ramps or Equivalent.		N/A	Ramp Length (in)	49.0	Yes	Ramp Slope (%)	7.3
			No	Ramp Width (in)	33.0	No	Ramp XSlope (%)	4.5
			N/A	Flare Type LT	N/A	N/A	Flare Type RT	N/A
			N/A	Flare Slope LT (%)	N/A	N/A	Flare Slope RT (%)	N/A
			N/A	Flare Traversable LT?	N/A	N/A	Flare Traversable RT?	N/A
			N/A	Landing Length (in)	N/A	N/A	DWS Provided?	N/A
			N/A	Landing Width (in)	N/A	N/A	DWS Contrast?	N/A
			N/A	Landing Slope (%)	N/A	N/A	DWS Length (in)	N/A
			N/A	Landing X Slope (%)	N/A	N/A	DWS Full Width?	N/A
Surveyor Notes:	N/A		N/A	Landing Curb? (Y/N)	N/A	N/A	DWS Offset (in)	N/A
			N/A	Shared Landing?	N/A			
	PROW/ADA:		N/A	Gutter Ponding?	N/A	N/A	Gutter Slope (%)	N/A
	Not Found, R304.5.1, R304.5.3		N/A	Gutter Lip Ht (in)	N/A	N/A	Gutter X Slope (%)	N/A

N/A	Painted X Walk1?	No	N/A	Painted X Walk2?	No
				X Walk 1 Direction	To N		X Walk 2 Direction	To W
			N/A	X Walk 1 Width (in)	N/A	N/A	X Walk 2 Width (in)	N/A
				X Walk 1 Slope (%)	3.8		X Walk 2 Slope (%)	1.9
				X Walk 1 X Slope (%)	0.0		X Walk 2 X Slope (%)	2.4
			N/A	Ramp inside XWalk1?	N/A	N/A	Ramp inside XWalk2?	N/A
			Road Slope (%)	0.8	N/A	Clear Space?	N/A	
			Road X Slope (%)	4.1	N/A	Clear Space to XWalk (in)	N/A	
		N/A	Any Obstructions?	N/A	N/A	Storm Grate/Utility Hazard?	N/A	
			Obstruction Type			Storm Grate/Utility Type		
					N/A		N/A	
					Yes	Surface Condition? (G/P)	Good	
							</

Total Cost: \$ 3200.00
