Access Compliance Report

Public Rights-of-Way

(Curb Ramps)

Intersection ID: 8535	Main Street: BROOKSHIRE_BV	Cross Street: NELSON_AV	Location: NW
ADA ID: 836425E55E0B	Ramp Type: Perp	Initial Pass/Fail: Fail	Overall Compliance: No
Severity Score: 33.75			
Codes/Mitigation Info/Possible Solution		Field Measurements/Component Compliance

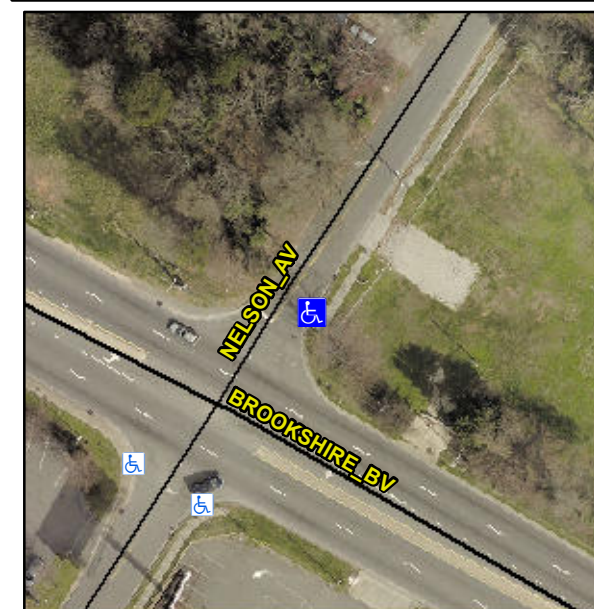
Not Found, R304.5.1, R304.5.3

Compliance	Description	Data	Compliance	Description	Data
N/A	Ramp Length (in)	52.0	Yes	Ramp Slope (%)	5.4
No	Ramp Width (in)	46.0	No	Ramp XSlope (%)	11.1
N/A	Flare Type LT	N/A	N/A	Flare Type RT	N/A
N/A	Flare Slope LT (%)	N/A	N/A	Flare Slope RT (%)	N/A
N/A	Flare Traversable LT?	N/A	N/A	Flare Traversable RT?	N/A
N/A	Landing Length (in)	N/A	N/A	DWS Provided?	N/A
N/A	Landing Width (in)	N/A	N/A	DWS Contrast?	N/A
N/A	Landing Slope (%)	N/A	N/A	DWS Length (in)	N/A
N/A	Landing X Slope (%)	N/A	N/A	DWS Full Width?	N/A
N/A	Landing Curb? (Y/N)	N/A	N/A	DWS Offset (in)	N/A
N/A	Shared Landing?	N/A			
N/A	Gutter Ponding?	N/A	N/A	Gutter Slope (%)	N/A
N/A	Gutter Lip Ht (in)	N/A	N/A	Gutter X Slope (%)	N/A
N/A	Painted X Walk1?	No	N/A	Painted X Walk2?	N/A
	X Walk 1 Direction	To W		X Walk 2 Direction	N/A
N/A	X Walk 1 Width (in)	N/A	N/A	X Walk 2 Width (in)	N/A
	X Walk 1 Slope (%)	5.4		X Walk 2 Slope (%)	N/A
	X Walk 1 X Slope (%)	7.9		X Walk 2 X Slope (%)	N/A

Possible Solutions:

Remove & Replace Entire Ramp.

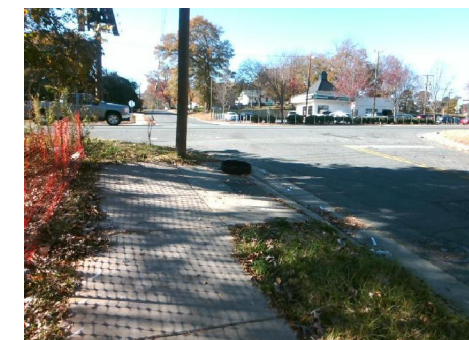
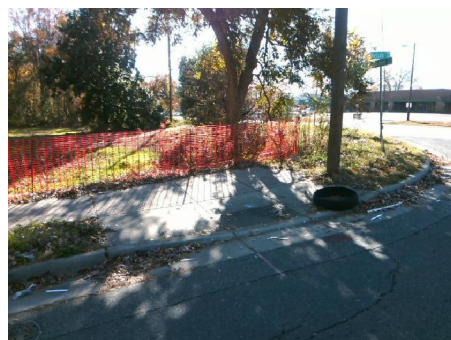
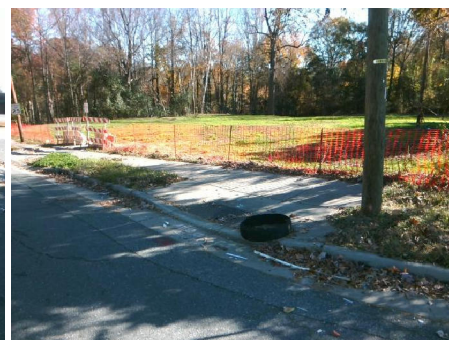
N/A	Ramp inside XWalk1?	N/A	N/A	Ramp inside XWalk2?	N/A
	Road Slope (%)	7.9	N/A	Clear Space?	N/A
	Road X Slope (%)	5.4	N/A	Clear Space to XWalk (in)	N/A
N/A	Any Obstructions?	N/A	N/A	Storm Grate/Utility Hazard?	N/A
	Obstruction Type			Storm Grate/Utility Type	
		N/A			N/A
			Yes	Surface Condition? (G/P)	Good
