Access Compliance Report

Public Rights-of-Way

(Curb Ramps)

Intersection ID: 45795	Main Street: SHELLVIEW_LN	Cross Street: WINDING_RIVER_DR	Location: NE
ADA ID: 8365DCBA2DAC	Ramp Type: BlendTrans1	Initial Pass/Fail: Fail	Overall Compliance: No
Severity Score: 33.75			
Codes/Mitigation Info/Possible Solution		Field Measurements/Component Compliance

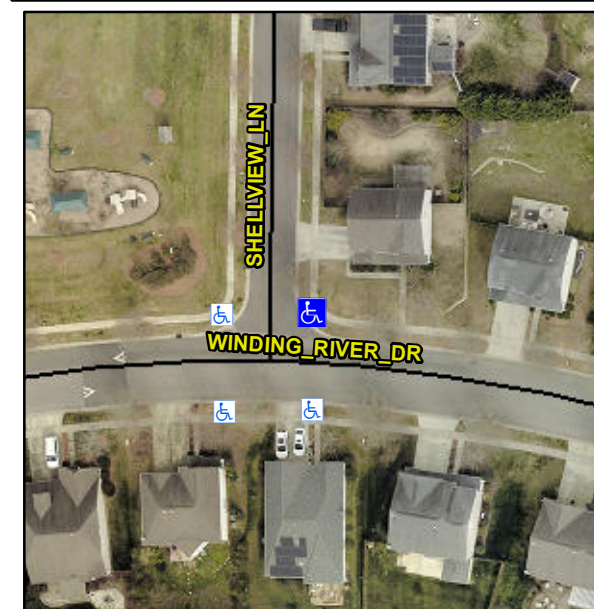
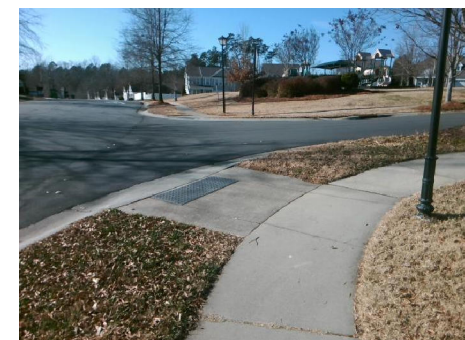
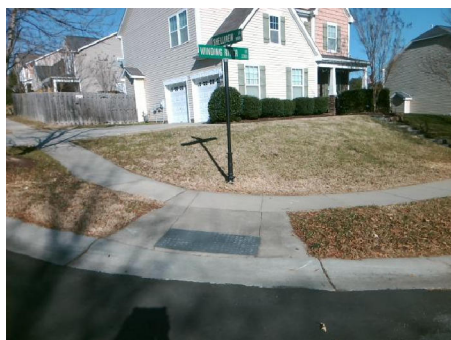
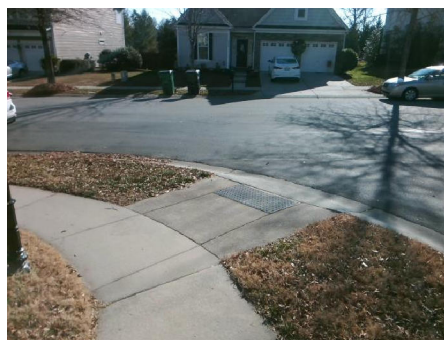
Compliance	Description	Data	Compliance	Description	Data
N/A	Ramp Length (in)	73.0	Yes	BlendTrans Slope (%)	4.2
No	Ramp Width (in)	47.5	No	BlendTrans XSlope (%)	9.0
N/A	Flare Type LT	N/A	N/A	Flare Type RT	N/A
N/A	Flare Slope LT (%)	N/A	N/A	Flare Slope RT (%)	N/A
N/A	Flare Traversable LT?	N/A	N/A	Flare Traversable RT?	N/A
N/A	Landing Length (in)	N/A	N/A	DWS Provided?	N/A
N/A	Landing Width (in)	N/A	N/A	DWS Contrast?	N/A
N/A	Landing Slope (%)	N/A	N/A	DWS Length (in)	N/A
N/A	Landing X Slope (%)	N/A	N/A	DWS Full Width?	N/A
N/A	Landing Curb? (Y/N)	N/A	N/A	DWS Offset (in)	N/A
N/A	Shared Landing?	N/A			
N/A	Gutter Ponding?	N/A	N/A	Gutter Slope (%)	N/A
N/A	Gutter Lip Ht (in)	N/A	N/A	Gutter X Slope (%)	N/A
N/A	Painted X Walk1?	No	N/A	Painted X Walk2?	No
	X Walk 1 Direction	To W		X Walk 2 Direction	To S
	X Walk 1 Width (in)	N/A		X Walk 2 Width (in)	N/A
	X Walk 1 Slope (%)	2.7		X Walk 2 Slope (%)	1.9
	X Walk 1 X Slope (%)	7.9		X Walk 2 X Slope (%)	4.8

N/A	Ramp inside XWalk1?	N/A	N/A	Ramp inside XWalk2?	N/A
	Road Slope (%)	8.0		Clear Space?	N/A
	Road X Slope (%)	0.7	N/A	Clear Space to XWalk (in)	N/A
N/A	Any Obstructions?	N/A	N/A	Storm Grate/Utility Hazard?	N/A
	Obstruction Type			Storm Grate/Utility Type	
		N/A			N/A
			Yes	Surface Condition? (G/P)	Good
			N/A	Curb Slope (%)	2.1

Possible Solutions:

Remove & Replace Curb Ramp With Two New Directional Ramps or Equivalent.

R304.5.1, R304.5.3
