# Access Compliance Report

## Public Rights-of-Way

### (Curb Ramps)

| Intersection ID: 10027881 | Main Street: HAMPSHIRE_HILL_RD | Cross Street: N/A | Location: | S |

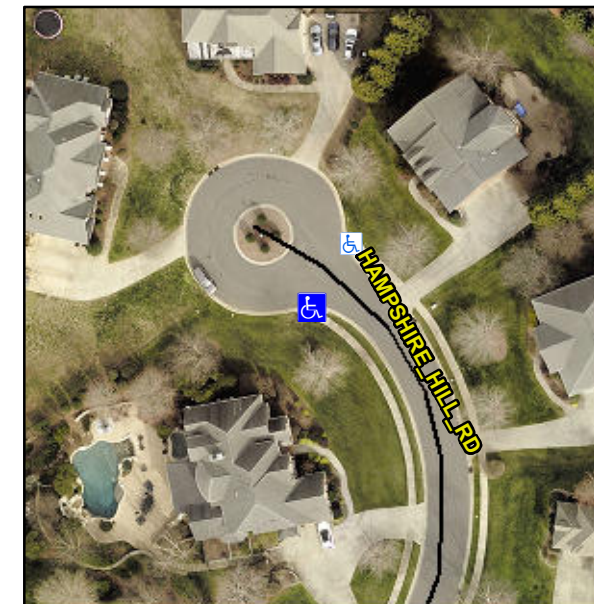
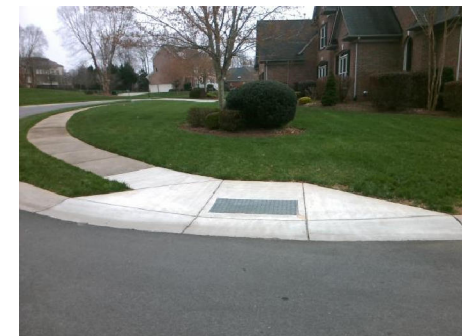
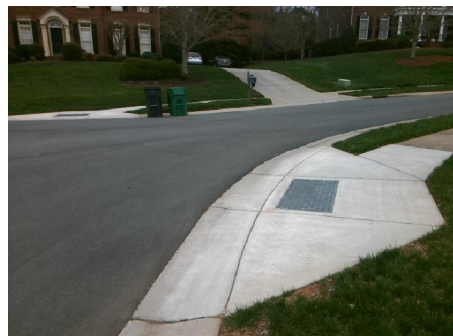
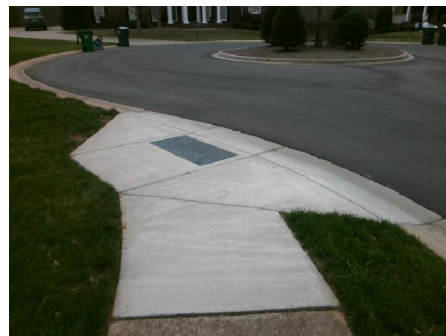
| ADA ID: 837290483212 | Ramp Type: BlendTrans2 | Initial Pass/Fail: Pass | Overall Compliance: No | Severity Score: 2.5 |

| Compliance | Description | Data | Compliance | Description | Data |
|---|---|---|---|---|---|
| N/A | Landing X Slope (%) | N/A | No | DWS Full Width? | No |
| N/A | Landing Curb? (Y/N) | No | No | DWS Offset (in) | 7.5 |
| Yes | Gutter Lip Ht (in) | 0.0 | No | Gutter X Slope (%) | 2.9 |

Possible Solutions:

**Remove & Replace Detectable Warning System. Remove & Replace Gutter.**

**R305.1.4, R305.2, R304.5.3**
