Access Compliance Report Public Rights-of-Way (Curb Ramps)

Intersection ID: 7035 Main Street: OLD_MT_HOLLY_RD Cross Street: WINDY_VALLEY_DR Location: **Overall Compliance: No** ADA ID: 8375C803B15D Ramp Type: Perp Initial Pass/Fail: Fail **Severity Score:** 22.5

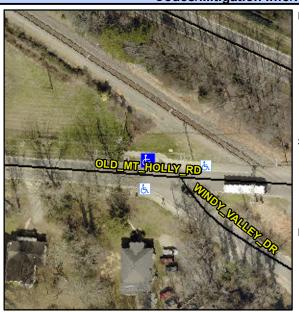
Field Measurements/Component Compliance							
Compliance Description		Data	Comp	liance Description	Data		
N/A	Ramp Length (in)	73.0	No	Ramp Slope (%)	10.3		
No	Ramp Width (in)	46.0	No	Ramp XSlope (%)	3.0		
N/A	Flare Type LT	N/A	N/A	Flare Type RT	N/A		
N/A	Flare Slope LT (%)	N/A	N/A	Flare Slope RT (%)	N/A		
N/A	Flare Traversable LT?	N/A	N/A	Flare Traversable RT?	N/A		
N/A	Landing Length (in)	N/A	N/A	DWS Provided?	N/A		
N/A	Landing Width (in)	N/A	N/A	DWS Contrast?	N/A		
N/A	Landing Slope (%)	N/A	N/A	DWS Length (in)	N/A		
N/A	Landing X Slope (%)	N/A	N/A	DWS Full Width?	N/A		
N/A	Landing Curb? (Y/N)	N/A	N/A	DWS Offset (in)	N/A		
N/A	Shared Landing?	N/A					
N/A	Gutter Ponding?	N/A	N/A	Gutter Slope (%)	N/A		
N/A	Gutter Lip Ht (in)	N/A	N/A	Gutter X Slope (%)	N/A		
N/A	Painted X Walk1?	No	N/A	Painted X Walk2?	N/A		
	X Walk 1 Direction	To S		X Walk 2 Direction	N/A		
N/A	X Walk 1 Width (in)	N/A	N/A	X Walk 2 Width (in)	N/A

X Walk 1 Slope (%)	3.2		X Walk 2 Slope (%)	N/A		
	X Walk 1 X Slope (%)	1.3		X Walk 2 X Slope (%)	N/A		
N/A	Ramp inside XWalk1?	N/A	N/A	Ramp inside XWalk2?	N/A		
	Road Slope (%)	N/A	N/A	Clear Space?	N/A		
	Road X Slope (%)	N/A	N/A	Clear Space to XWalk (in)	N/A		
N/A	Any Obstructions?	N/A	N/A	Storm Grate/Utility Hazard?	N/A		
	Obstruction Type			Storm Grate/Utility Type			
		N/A			N/A		
			Yes	Surface Condition? (G/P)	Good

T COCIDIO COIGION		
Possible Solutions:	<u>c</u>	
Remove & Replace Entire Ramp.		
·	N	
	N	
	N	
	N	
	N	
Surveyor Notes:	N	
N/A	N	
	N	
	N	
	N	
PROW/ADA:	N	
Not Found, R304.5.1, R304.2.2,	N	
R304.5.3	N	
	N
