Access Compliance Report

Public Rights-of-Way

(Curb Ramps)

Intersection ID: 10036601	Main Street: RUSHMORE_DR	Cross Street: N/A	Location: NW
ADA ID: 8376CDAA0370	Ramp Type: PerpDiag	Initial Pass/Fail: Fail	Overall Compliance: No
		Severity Score: 37.5

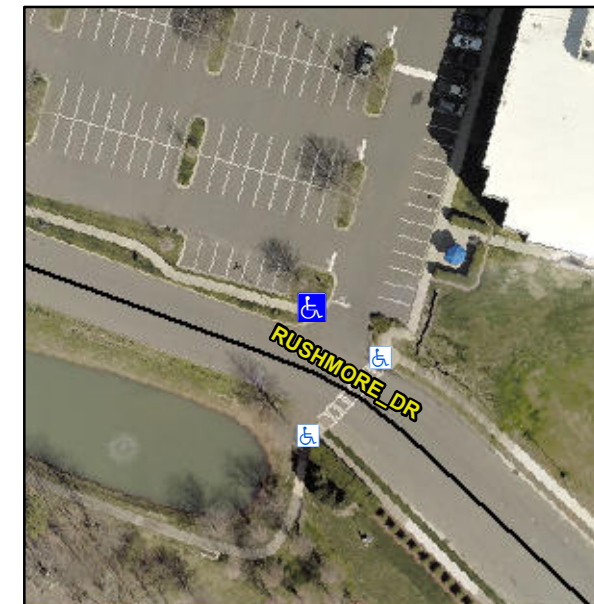
R304.2.2, R304.5.3

Compliance	Description	Data	Compliance	Description	Data
N/A	Ramp Length (in)	83.0	No	Ramp Slope (%)	12.1
Yes	Ramp Width (in)	48.0	No	Ramp XSlope (%)	6.3
N/A	Flare Type LT	N/A	N/A	Flare Type RT	N/A
N/A	Flare Slope LT (%)	N/A	N/A	Flare Slope RT (%)	N/A
N/A	Flare Traversable LT?	N/A	N/A	Flare Traversable RT?	N/A
N/A	Landing Length (in)	N/A	N/A	DWS Provided?	N/A
N/A	Landing Width (in)	N/A	N/A	DWS Contrast?	N/A
N/A	Landing Slope (%)	N/A	N/A	DWS Length (in)	N/A
N/A	Landing X Slope (%)	N/A	N/A	DWS Full Width?	N/A
N/A	Landing Curb? (Y/N)	N/A	N/A	DWS Offset (in)	N/A
N/A	Shared Landing?	N/A			
N/A	Gutter Ponding?	N/A	N/A	Gutter Slope (%)	N/A
N/A	Gutter Lip Ht (in)	N/A	N/A	Gutter X Slope (%)	N/A
N/A	Painted X Walk1?	No	N/A	Painted X Walk2?	No
	X Walk 1 Direction	To SE		X Walk 2 Direction	To NE
N/A	X Walk 1 Width (in)	N/A	N/A	X Walk 2 Width (in)	N/A
	X Walk 1 Slope (%)	5.7		X Walk 2 Slope (%)	3.6
	X Walk 1 X Slope (%)	2.9		X Walk 2 X Slope (%)	5.9

N/A	Ramp inside XWalk1?	N/A	N/A	Ramp inside XWalk2?	N/A
	Road Slope (%)	3.4	N/A	Clear Space?	N/A
	Road X Slope (%)	3.9	N/A	Clear Space to XWalk (in)	N/A
N/A	Any Obstructions?	N/A	N/A	Storm Grate/Utility Hazard?	N/A
	Obstruction Type			Storm Grate/Utility Type	
		N/A			N/A
			Yes	Surface Condition? (G/P)	Good

Remove & Replace Curb Ramp With Two New Directional Ramps or Equivalent.
