Access Compliance Report Public Rights-of-Way (Curb Ramps)

Intersection ID: 9594 Main Street: CADMIUM CT **Cross Street: MOODY RD** Location: W Initial Pass/Fail: Fail **Overall Compliance: No** ADA ID: 8385D4D8C902 Ramp Type: Perp Severity Score: 13.75

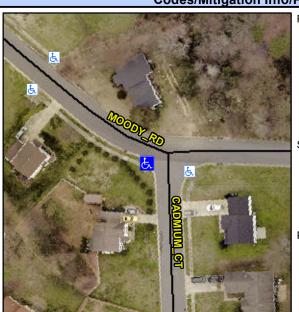
Street 1 Name	CADMIUM CT
Stop Condition-Street 2	StopSign
Street 2 Name	N/A
Stop Condition-Street 1	N/A

1	Possible Solutions:	Compli	ance	Description
	Remove & Replace Entire Ramp.	N/A	Ramp	Length (in)
Š	•	Yes	Ramp	Width (in)
		N/A	Flare Type LT Flare Slope LT (%) Flare Traversable L1	
		N/A		
		N/A		
2		N/A	Landi	ng Length (in)
No.	Surveyor Notes:	N/A	Landi	ng Width (in)
	N/A	N/A	Landi	ng Slope (%)
-		N/A	Landi	ng X Slope (%
		N/A	Landi	ng Curb? (Y/N
		N/A	Share	ed Landing?
Spent .	PROW/ADA:	N/A	Gutte	r Ponding?
00	Not Found, R304.2.2, R304.5.3	N/A	Gutte	r Lip Ht (in)
100 mg		N/A	Painte	ed X Walk1?
			X Wa	lk 1 Direction
		N/A	X Wa	lk 1 Width (in)
			X Wa	lk 1 Slope (%)
			X Wa	lk 1 X Slope (%
		N/A	Ramp	inside XWalk
			Road	Slope (%)
			Road	Y Slone (%)
