Access Compliance Report

Public Rights-of-Way

(Curb Ramps)

Intersection ID: 28144	Main Street: DONNINGTON_DR	Cross Street: FULLER_PL	Location:	N
ADA ID: 838620366A14	Ramp Type: PerpDiag	Initial Pass/Fail: Fail	Overall Compliance: No	Severity Score: 37.5
Codes/Mitigation Info/Possible Solution		Field Measurements/Component Compliance

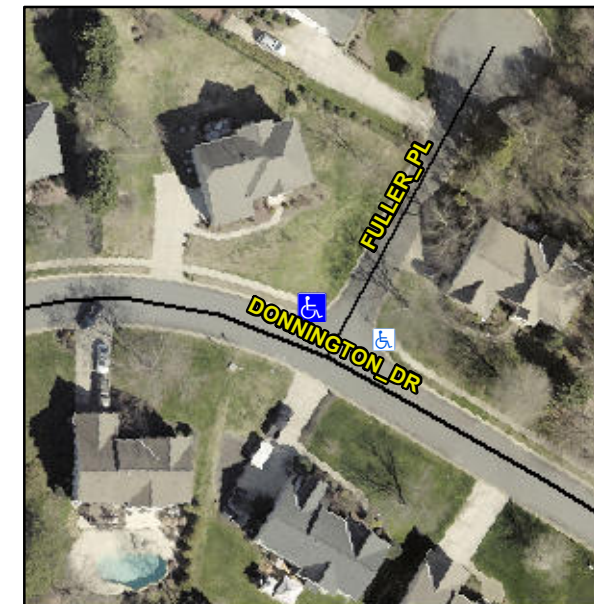
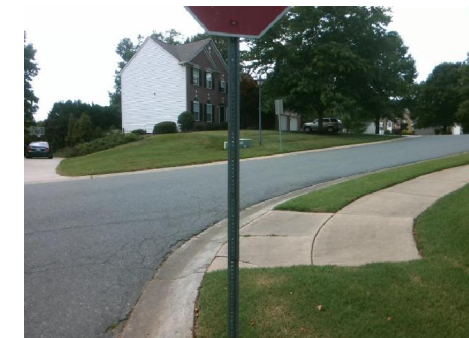
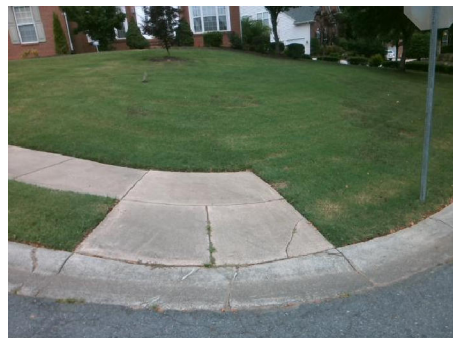
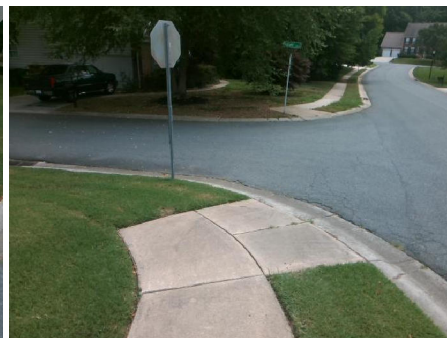
Not Found, R304.2.2, R304.5.3

Compliance	Description	Data	Compliance	Description	Data
N/A	Ramp Length (in)	100.0	No	Ramp Slope (%)	11.2
Yes	Ramp Width (in)	99.0	No	Ramp XSlope (%)	10.8
N/A	Flare Type LT	N/A	N/A	Flare Type RT	N/A
N/A	Flare Slope LT (%)	N/A	N/A	Flare Slope RT (%)	N/A
N/A	Flare Traversable LT?	N/A	N/A	Flare Traversable RT?	N/A
N/A	Landing Length (in)	N/A	N/A	DWS Provided?	N/A
N/A	Landing Width (in)	N/A	N/A	DWS Contrast?	N/A
N/A	Landing Slope (%)	N/A	N/A	DWS Length (in)	N/A
N/A	Landing X Slope (%)	N/A	N/A	DWS Full Width?	N/A
N/A	Landing Curb? (Y/N)	N/A	N/A	DWS Offset (in)	N/A
N/A	Shared Landing?	N/A			
N/A	Gutter Ponding?	N/A	N/A	Gutter Slope (%)	N/A
N/A	Gutter Lip Ht (in)	N/A	N/A	Gutter X Slope (%)	N/A
N/A	Painted X Walk1?	No	N/A	Painted X Walk2?	No
	X Walk 1 Direction	To SW		X Walk 2 Direction	To SE
N/A	X Walk 1 Width (in)	N/A	N/A	X Walk 2 Width (in)	N/A
	X Walk 1 Slope (%)	9.4		X Walk 2 Slope (%)	3.8
	X Walk 1 X Slope (%)	5.9		X Walk 2 X Slope (%)	7.6

N/A	Ramp inside XWalk1?	N/A	N/A	Ramp inside XWalk2?	N/A
	Road Slope (%)	9.1	N/A	Clear Space?	N/A
	Road X Slope (%)	2.4	N/A	Clear Space to XWalk (in)	N/A
N/A	Any Obstructions?	N/A	N/A	Storm Grate/Utility Hazard?	N/A
	Obstruction Type			Storm Grate/Utility Type	
		N/A			N/A
			Yes	Surface Condition? (G/P)	Good

Remove & Replace Curb Ramp With Two New Directional Ramps or Equivalent.
