Access Compliance Report

Public Rights-of-Way

(Curb Ramps)

| Intersection ID: 14872 | Main Street: DILWORTH_RD_EAST | Cross Street: ISLEWORTH_AV | Location: SW |

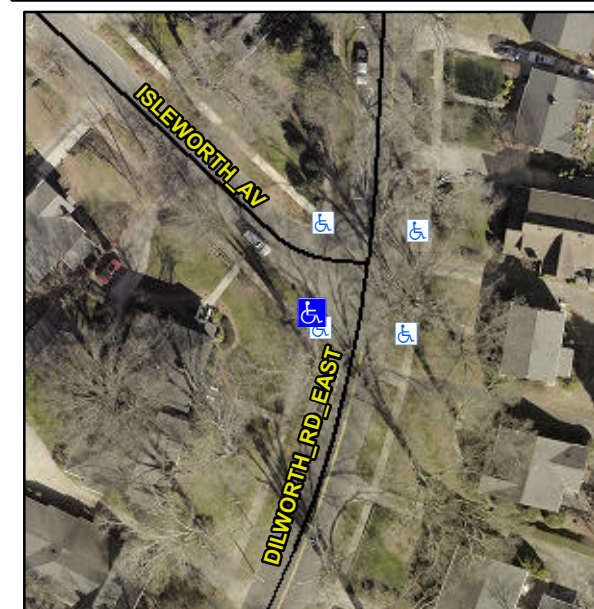
| ADA ID: 838D7563902D | Ramp Type: Directional1 | Initial Pass/Fail: Fail | Overall Compliance: No |
| Severity Score: 1.25 | | | |

R304.5.3

| Compliance | Description | Data | Compliance | Description | Data |
|---|---|---|---|---|---|
| No | Ramp XSlope (%) | 2.2 | | | |
| N/A | Gutter Ponding? | Yes | N/A | Gutter Slope (%) | N/A |

Remove & Replace Entire Ramp.

\$ 1600.00
