## Access Compliance Report Public Rights-of-Way (Curb Ramps)

Intersection ID: 17570 Main Street: RANDOLPH\_RD Cross Street: WOODLARK\_LN Location: NW

ADA ID: 83978FFEB56C Ramp Type: PerpDiag Initial Pass/Fail: Fail Overall Compliance: No Severity Score: 25

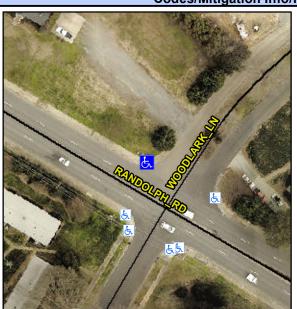
Field Measurements/Component Compliance							
	Compliance Description		Data	Compliance Description		Description	Data
	N/A	Ramp Length (in)	48.0	No	Ramp	Slope (%)	8.6
	Yes	Ramp Width (in)	48.0	No	Ramp	XSlope (%)	5.4
	N/A	Flare Type LT	N/A	N/A	Flare	Type RT	N/A
	N/A	Flare Slope LT (%)	N/A	N/A	Flare	Slope RT (%)	N/A
	N/A	Flare Traversable LT?	N/A	N/A	Flare	Traversable RT?	N/A
	N/A	Landing Length (in)	N/A	N/A	DWS	Provided?	N/A
	N/A	Landing Width (in)	N/A	N/A	DWS	Contrast?	N/A
	N/A	Landing Slope (%)	N/A	N/A	DWS	Length (in)	N/A
	N/A	Landing X Slope (%)	N/A	N/A	DWS	Full Width?	N/A
	N/A	Landing Curb? (Y/N)	N/A	N/A	DWS	Offset (in)	N/A
	N/A	Shared Landing?	N/A				
	N/A	Gutter Ponding?	N/A	N/A	Gutte	r Slope (%)	N/A
	N/A	Gutter Lip Ht (in)	N/A	N/A	Gutte	r X Slope (%)	N/A
	N/A	Painted X Walk1?	No	N/A	Paint	ed X Walk2?	No
		X Walk 1 Direction	To SW		X Wa	lk 2 Direction	To SE
	N/A	X Walk 1 Width (in)	N/A	N/A	X Wa	lk 2 Width (in)	N/A

X Walk 1 Slope (%)	9.6		X Wa	lk 2 Slope (%)	3.7
		X Walk 1 X Slope (%)	3.5		X Wa	lk 2 X Slope (%)	8.7
	N/A	Ramp inside XWalk1?	N/A	N/A	Ramp	inside XWalk2?	N/A
		Road Slope (%)	4.3	N/A	Clear	Space?	N/A
		Road X Slope (%)	7.8	N/A	Clear	Space to XWalk (in)	N/A
	N/A	Any Obstructions?	N/A	N/A	Storm	n Grate/Utility Hazard?	N/A
		Obstruction Type			Storm	n Grate/Utility Type	
			N/A				N/A
				Yes	Surfa	ce Condition? (G/P)	Good

Remove & Replace Curb Ramp With
Two New Directional Ramps or
Equivalent.

R304.2.2, R304.5.3
