Access Compliance Report

Public Rights-of-Way

(Curb Ramps)

Intersection ID: 23117	Main Street: CEDAR_CROSSINGS_DR	Cross Street: ERWIN_RD	Location: NW
ADA ID: 8398E492B099	Ramp Type: PerpDiag	Initial Pass/Fail: Fail	Overall Compliance: No
		Severity Score: 12.5

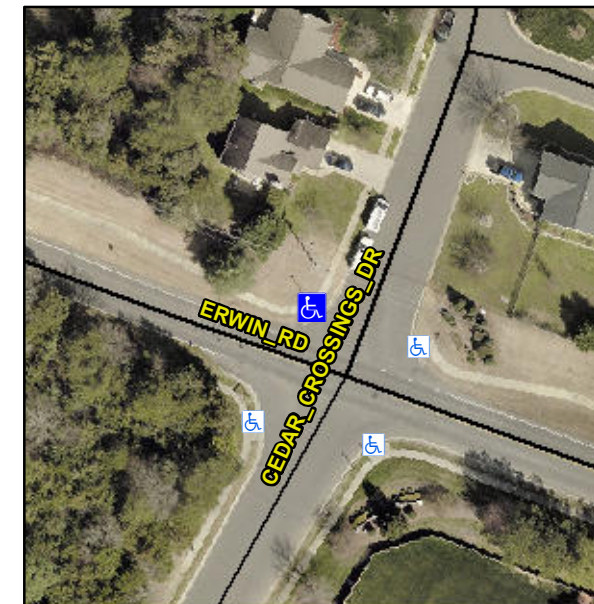
Compliance	Description	Data	Compliance	Description	Data
N/A	Ramp Length (in)	48.0	No	Ramp Slope (%)	9.1
Yes	Ramp Width (in)	48.0	Yes	Ramp XSlope (%)	1.7
N/A	Flare Type LT	N/A	N/A	Flare Type RT	N/A
N/A	Flare Slope LT (%)	N/A	N/A	Flare Slope RT (%)	N/A
N/A	Flare Traversable LT?	N/A	N/A	Flare Traversable RT?	N/A
N/A	Landing Length (in)	N/A	N/A	DWS Provided?	N/A
N/A	Landing Width (in)	N/A	N/A	DWS Contrast?	N/A
N/A	Landing Slope (%)	N/A	N/A	DWS Length (in)	N/A
N/A	Landing X Slope (%)	N/A	N/A	DWS Full Width?	N/A
N/A	Landing Curb? (Y/N)	N/A	N/A	DWS Offset (in)	N/A
N/A	Shared Landing?	N/A			
N/A	Gutter Ponding?	N/A	N/A	Gutter Slope (%)	N/A
N/A	Gutter Lip Ht (in)	N/A	N/A	Gutter X Slope (%)	N/A
N/A	Painted X Walk1?	No	N/A	Painted X Walk2?	No
	X Walk 1 Direction	To SW		X Walk 2 Direction	To SE
N/A	X Walk 1 Width (in)	N/A	N/A	X Walk 2 Width (in)	N/A
	X Walk 1 Slope (%)	1.9		X Walk 2 Slope (%)	0.7
	X Walk 1 X Slope (%)	0.4		X Walk 2 X Slope (%)	2.7

N/A	Ramp inside XWalk1?	N/A	N/A	Ramp inside XWalk2?	N/A
	Road Slope (%)	1.8	N/A	Clear Space?	N/A
	Road X Slope (%)	3.8	N/A	Clear Space to XWalk (in)	N/A
N/A	Any Obstructions?	N/A	N/A	Storm Grate/Utility Hazard?	N/A
	Obstruction Type			Storm Grate/Utility Type	
		N/A			N/A
			Yes	Surface Condition? (G/P)	Good

Remove & Replace Curb Ramp With Two New Directional Ramps or Equivalent.
