# Access Compliance Report

## Public Rights-of-Way

### (Curb Ramps)

| Intersection ID: 5609 | Main Street: HAMILTON_CR | Cross Street: SUNSET_RD | Location: SW |

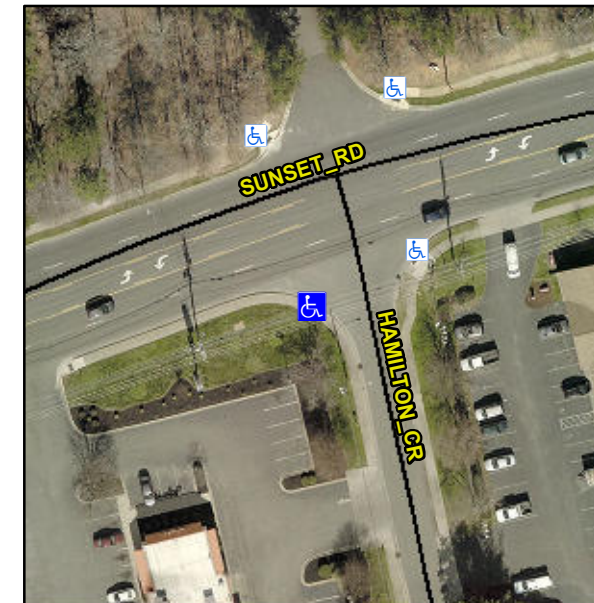
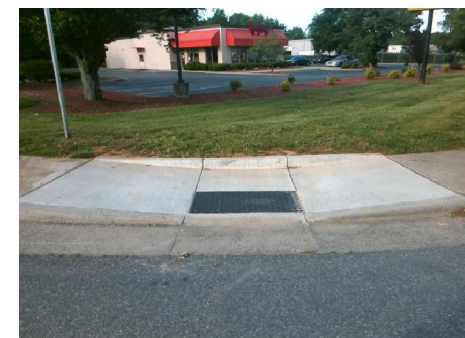
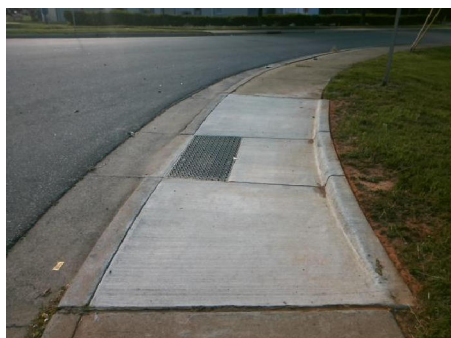
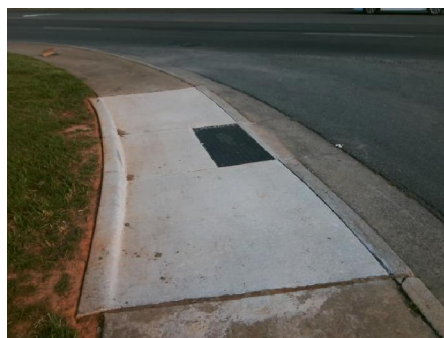
| ADA ID: 839C46D248AB | Ramp Type: BlendTrans2 | Initial Pass/Fail: Pass | Overall Compliance: No |
| | | Severity Score: 0.25 | |

**Not Found, R304.5.3**

| Compliance | Description | Data | Compliance | Description | Data |
|---|---|---|---|---|---|
| Yes | Ramp Width (in) | 48.0 | No | BlendTrans XSlope (%) | 2.7 |
| Yes | Gutter Lip Ht (in) | 0.0 | No | Gutter X Slope (%) | 2.1 |
| | | | No | Curb Slope (%) | 5.9 |

**Remove & Replace Curb Ramp With Two New Directional Ramps or Equivalent. Remove & Replace Gutter.**
