Access Compliance Report Public Rights-of-Way (Curb Ramps)

Intersection ID: 52172 Main Street: BEARLING WY Cross Street: AVERY_MEADOWS_DR Location: NW ADA ID: 83A20B5362F7 Ramp Type: Perp Initial Pass/Fail: Fail **Overall Compliance: No Severity Score:** 10

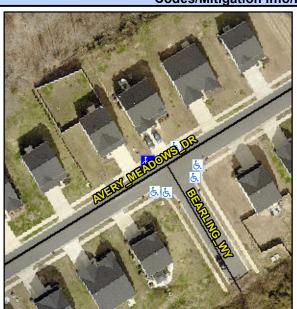
Compliance Description Data Compliance Description N/A Ramp Length (in) 47.5 Yes Ramp Slope (%)	Data 6.7 3.3
N/A Ramp Length (in) 47.5 Vas Ramp Slone (%)	
Trans Length (III)	3.3
No Ramp Width (in) 47.5 Yes Ramp XSlope (%)	
N/A Flare Type LT N/A N/A Flare Type RT	N/A
N/A Flare Slope LT (%) N/A N/A Flare Slope RT (%)	N/A
N/A Flare Traversable LT? N/A N/A Flare Traversable RT?	N/A
N/A Landing Length (in) N/A N/A DWS Provided?	N/A
N/A Landing Width (in) N/A N/A DWS Contrast?	N/A
N/A Landing Slope (%) N/A N/A DWS Length (in)	N/A
N/A Landing X Slope (%) N/A N/A DWS Full Width?	N/A
N/A Landing Curb? (Y/N) N/A N/A DWS Offset (in)	N/A
N/A Shared Landing? N/A	
N/A Gutter Ponding? N/A N/A Gutter Slope (%)	N/A
N/A Gutter Lip Ht (in) N/A N/A Gutter X Slope (%)	N/A
N/A Painted X Walk1? No N/A Painted X Walk2?	N/A
X Walk 1 Direction To S X Walk 2 Direction	N/A
N/A X Walk 1 Width (in) N/A N/A X Walk 2 Width (in)	N/A
X Walk 1 Slope (%) 2.3 X Walk 2 Slope (%)	N/A

X Walk 1 X Slope (%) 5.4 X Walk 2 X Slope (%)	N/A
N/A Ramp inside XWalk1? N/A Ramp inside XWalk2?	N/A
Road Slope (%) N/A Clear Space?	N/A
Road X Slope (%) N/A Clear Space to XWalk (in)	N/A
N/A Any Obstructions? N/A N/A Storm Grate/Utility Hazard?	N/A
Obstruction Type Storm Grate/Utility Type	
N/A	N/A
Yes Surface Condition? (G/P)	Good

AVEEY MEADOWS DR Street 1 Name Stop Condition-Street 2 None Street 2 Name N/A Stop Condition-Street 1 N/A Possible Solutions: Remove & Replace Entire Ramp. Surveyor Notes: N/A PROW/ADA: Not Found, R304.5.1
