# Access Compliance Report

## Public Rights-of-Way

### (Curb Ramps)

Intersection ID: 8847	Main Street: E_SUGAR_CREEK_RD	Cross Street: N_TRYON_ST	Location: SW
ADA ID: 83A3E29C01DD	Ramp Type: Perp	Initial Pass/Fail: Fail	Overall Compliance: No
Severity Score: 18.75			
Codes/Mitigation Info/Possible Solution		Field Measurements/Component Compliance

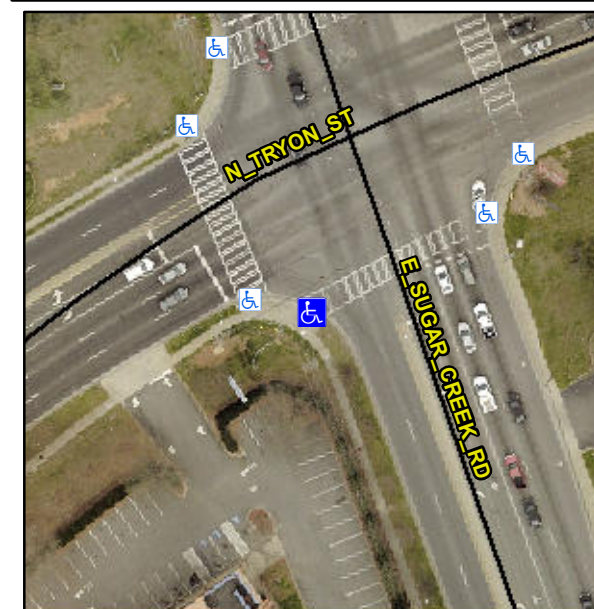
**Not Found, R304.5.1**

Compliance	Description	Data	Compliance	Description	Data
N/A	Ramp Length (in)	111.5	Yes	Ramp Slope (%)	5.8
No	Ramp Width (in)	34.5	Yes	Ramp XSlope (%)	4.7
N/A	Flare Type LT	N/A	N/A	Flare Type RT	N/A
N/A	Flare Slope LT (%)	N/A	N/A	Flare Slope RT (%)	N/A
N/A	Flare Traversable LT?	N/A	N/A	Flare Traversable RT?	N/A
N/A	Landing Length (in)	N/A	N/A	DWS Provided?	N/A
N/A	Landing Width (in)	N/A	N/A	DWS Contrast?	N/A
N/A	Landing Slope (%)	N/A	N/A	DWS Length (in)	N/A
N/A	Landing X Slope (%)	N/A	N/A	DWS Full Width?	N/A
N/A	Landing Curb? (Y/N)	N/A	N/A	DWS Offset (in)	N/A
N/A	Shared Landing?	N/A			
N/A	Gutter Ponding?	N/A	N/A	Gutter Slope (%)	N/A
N/A	Gutter Lip Ht (in)	N/A	N/A	Gutter X Slope (%)	N/A
N/A	Painted X Walk1?	Yes	N/A	Painted X Walk2?	N/A
	X Walk 1 Direction	To E		X Walk 2 Direction	N/A
N/A	X Walk 1 Width (in)	145.0	N/A	X Walk 2 Width (in)	N/A
	X Walk 1 Slope (%)	0.6		X Walk 2 Slope (%)	N/A
	X Walk 1 X Slope (%)	4.7		X Walk 2 X Slope (%)	N/A

N/A	Ramp inside XWalk1?	Yes	N/A	Ramp inside XWalk2?	N/A
	Road Slope (%)	N/A	N/A	Clear Space?	N/A
	Road X Slope (%)	N/A	N/A	Clear Space to XWalk (in)	N/A
N/A	Any Obstructions?	N/A	N/A	Storm Grate/Utility Hazard?	N/A
	Obstruction Type			Storm Grate/Utility Type	
		N/A			N/A
		Yes		Surface Condition? (G/P)	Good

Possible Solutions:

**Remove & Replace Entire Ramp.**
