# Access Compliance Report

## Public Rights-of-Way

### (Curb Ramps)

| Intersection ID: 53746 | Main Street: SPRINGWOOD_ESTATE_DR | Cross Street: CANTERBURY_CASTLE_DR | Location: NE |

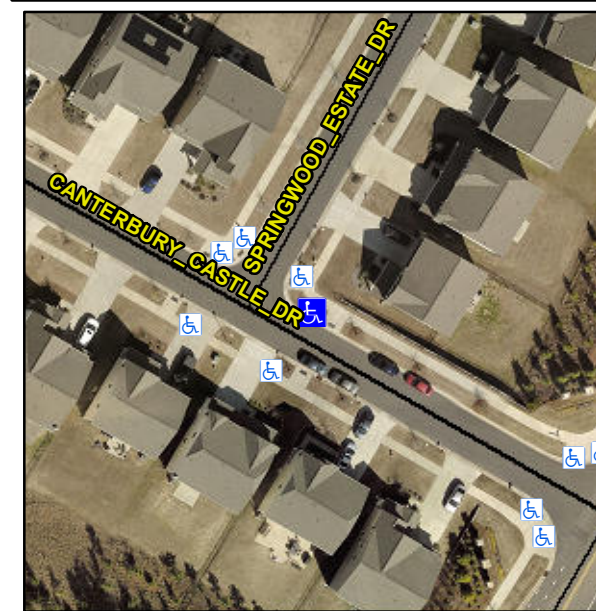
| ADA ID: 83AE1E6C8AC2 | Ramp Type: BlendTrans1 | Initial Pass/Fail: Fail | Overall Compliance: No |
| Severity Score: 12.5 | | | |

| Compliance | Description | Data | Compliance | Description | Data |
|---|---|---|---|---|---|
| Yes | Ramp Width (in) | 48.0 | No | BlendTrans XSlope (%) | 5.6 |

**Remove & Replace Curb Ramp With Two New Directional Ramps or Equivalent.**

**R304.5.3**

Total Cost: \$ 3200.00
