## **Access Compliance Report Public Rights-of-Way** (Curb Ramps)

Intersection ID: 10031826 Main Street: MILLWRIGHT\_LN Cross Street: N/A Location: SW **Overall Compliance: No Severity Score:** ADA ID: 83B8586941DC Ramp Type: Perp Initial Pass/Fail: Fail 25

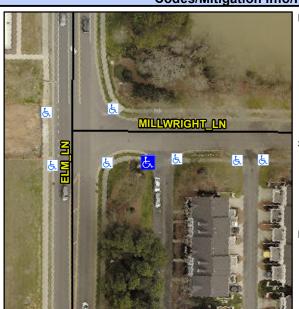
Field Measurements/Component Compliance						
Comp	liance Description	Data	Comp	liance Description	Data	
N/A	Ramp Length (in)	64.0	No	Ramp Slope (%)	10.6	
Yes	Ramp Width (in)	58.0	No	Ramp XSlope (%)	6.5	
N/A	Flare Type LT	N/A	N/A	Flare Type RT	N/A	
N/A	Flare Slope LT (%)	N/A	N/A	Flare Slope RT (%)	N/A	
N/A	Flare Traversable LT?	N/A	N/A	Flare Traversable RT?	N/A	
N/A	Landing Length (in)	N/A	N/A	DWS Provided?	N/A	
N/A	Landing Width (in)	N/A	N/A	DWS Contrast?	N/A	
N/A	Landing Slope (%)	N/A	N/A	DWS Length (in)	N/A	
N/A	Landing X Slope (%)	N/A	N/A	DWS Full Width?	N/A	
N/A	Landing Curb? (Y/N)	N/A	N/A	DWS Offset (in)	N/A	
N/A	Shared Landing?	N/A				
N/A	Gutter Ponding?	Yes	N/A	Gutter Slope (%)	N/A	
N/A	Gutter Lip Ht (in)	N/A	N/A	Gutter X Slope (%)	N/A	
N/A	Painted X Walk1?	No	N/A	Painted X Walk2?	N/A	
	X Walk 1 Direction	То Е		X Walk 2 Direction	N/A	
N/A	X Walk 1 Width (in)	N/A	N/A	X Walk 2 Width (in)	N/A	
	X Walk 1 Slope (%)	9.6		X Walk 2 Slope (%)	N/A

X Walk 1 X Slope (%)	0.2		X Walk 2 X Slope (%)	N/A	
N/A	Ramp inside XWalk1?	N/A	N/A	Ramp inside XWalk2?	N/A	
	Road Slope (%)	N/A	N/A	Clear Space?	N/A	
	Road X Slope (%)	N/A	N/A	Clear Space to XWalk (in)	N/A	
N/A	Any Obstructions?	N/A	N/A	Storm Grate/Utility Hazard?	N/A	
	Obstruction Type			Storm Grate/Utility Type		
		N/A			N/A	
			Yes	Surface Condition? (G/P)	Good

Possible Solutions:	<u>Cc</u>
Remove & Replace Entire Ramp.	N/
	Ye
	N/
	N/
	N/
	N/
Surveyor Notes:	N/
N/A	N/
	N/
	N/
	N/
PROW/ADA:	N/
Not Found, R304.2.2, R304.5.3	N/
	N/
	N/
	N/
