# Access Compliance Report

## Public Rights-of-Way

### (Curb Ramps)

Intersection ID: 50463	Main Street: EVERTON_DR	Cross Street: LENOX_POINTE_DR	Location: NW
ADA ID: 83BEB6E99AE0	Ramp Type: Perp	Initial Pass/Fail: Fail	Overall Compliance: No
			Severity Score: 13.75

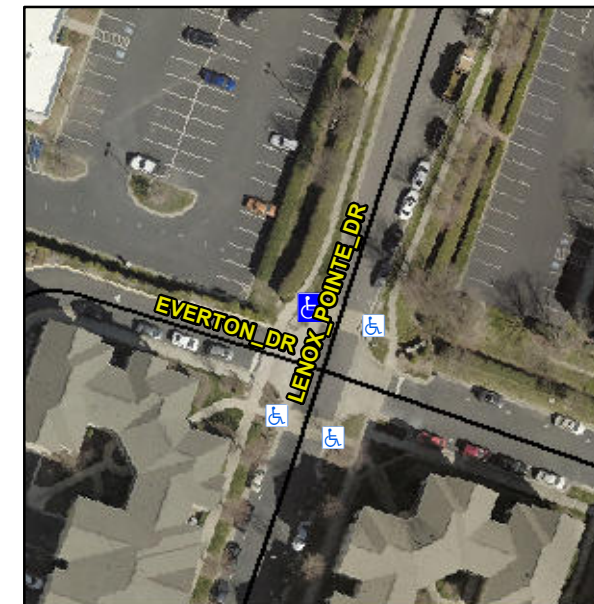
**Not Found, R304.2.2, R304.5.3**

Compliance	Description	Data	Compliance	Description	Data
N/A	Ramp Length (in)	126.0	No	Ramp Slope (%)	9.9
Yes	Ramp Width (in)	48.0	No	Ramp XSlope (%)	3.1
N/A	Flare Type LT	N/A	N/A	Flare Type RT	N/A
N/A	Flare Slope LT (%)	N/A	N/A	Flare Slope RT (%)	N/A
N/A	Flare Traversable LT?	N/A	N/A	Flare Traversable RT?	N/A
N/A	Landing Length (in)	N/A	N/A	DWS Provided?	N/A
N/A	Landing Width (in)	N/A	N/A	DWS Contrast?	N/A
N/A	Landing Slope (%)	N/A	N/A	DWS Length (in)	N/A
N/A	Landing X Slope (%)	N/A	N/A	DWS Full Width?	N/A
N/A	Landing Curb? (Y/N)	N/A	N/A	DWS Offset (in)	N/A
N/A	Shared Landing?	N/A			
N/A	Gutter Ponding?	N/A	N/A	Gutter Slope (%)	N/A
N/A	Gutter Lip Ht (in)	N/A	N/A	Gutter X Slope (%)	N/A
N/A	Painted X Walk1?	Yes	N/A	Painted X Walk2?	N/A
	X Walk 1 Direction	To E		X Walk 2 Direction	N/A
N/A	X Walk 1 Width (in)	144.0	N/A	X Walk 2 Width (in)	N/A
	X Walk 1 Slope (%)	2.5		X Walk 2 Slope (%)	N/A
	X Walk 1 X Slope (%)	1.4		X Walk 2 X Slope (%)	N/A

N/A	Ramp inside XWalk1?	Yes	N/A	Ramp inside XWalk2?	N/A
	Road Slope (%)	N/A	N/A	Clear Space?	N/A
	Road X Slope (%)	N/A	N/A	Clear Space to XWalk (in)	N/A
N/A	Any Obstructions?	N/A	N/A	Storm Grate/Utility Hazard?	N/A
	Obstruction Type			Storm Grate/Utility Type	
		N/A			N/A
			Yes	Surface Condition? (G/P)	Good

**Remove & Replace Entire Ramp.**
