# Access Compliance Report

## Public Rights-of-Way

### (Curb Ramps)

Intersection ID: 10581	Main Street: ANDERSON_ST	Cross Street: MEADOW_LN	Location: NE
ADA ID: 83C4DA03C93F	Ramp Type: PerpDiag	Initial Pass/Fail: Fail	Overall Compliance: No
		Severity Score: 25

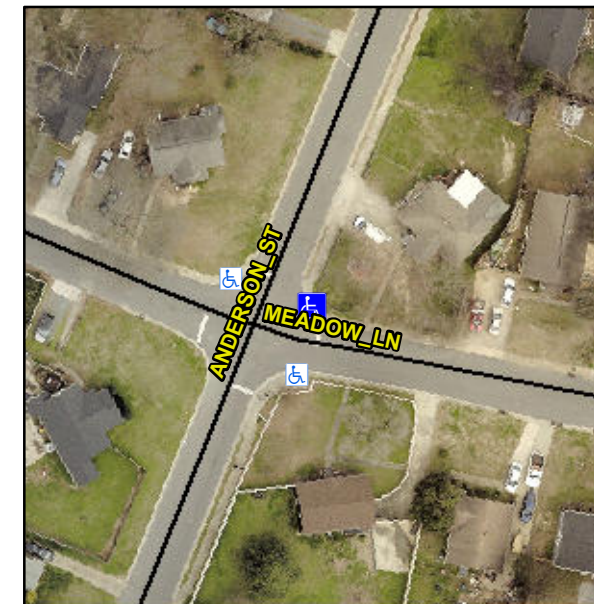
Compliance	Description	Data	Compliance	Description	Data
N/A	Ramp Length (in)	56.5	No	Ramp Slope (%)	11.9
Yes	Ramp Width (in)	48.0	No	Ramp XSlope (%)	5.8
N/A	Flare Type LT	N/A	N/A	Flare Type RT	N/A
N/A	Flare Slope LT (%)	N/A	N/A	Flare Slope RT (%)	N/A
N/A	Flare Traversable LT?	N/A	N/A	Flare Traversable RT?	N/A
N/A	Landing Length (in)	N/A	N/A	DWS Provided?	N/A
N/A	Landing Width (in)	N/A	N/A	DWS Contrast?	N/A
N/A	Landing Slope (%)	N/A	N/A	DWS Length (in)	N/A
N/A	Landing X Slope (%)	N/A	N/A	DWS Full Width?	N/A
N/A	Landing Curb? (Y/N)	N/A	N/A	DWS Offset (in)	N/A
N/A	Shared Landing?	N/A			
N/A	Gutter Ponding?	Yes	N/A	Gutter Slope (%)	N/A
N/A	Gutter Lip Ht (in)	N/A	N/A	Gutter X Slope (%)	N/A
N/A	Painted X Walk1?	No	N/A	Painted X Walk2?	No
	X Walk 1 Direction	To NW		X Walk 2 Direction	To SW
N/A	X Walk 1 Width (in)	N/A	N/A	X Walk 2 Width (in)	N/A
	X Walk 1 Slope (%)	4.5		X Walk 2 Slope (%)	0.2
	X Walk 1 X Slope (%)	0.2		X Walk 2 X Slope (%)	6.6

N/A	Ramp inside XWalk1?	N/A	N/A	Ramp inside XWalk2?	N/A
	Road Slope (%)	4.0	N/A	Clear Space?	N/A
	Road X Slope (%)	6.2	N/A	Clear Space to XWalk (in)	N/A
N/A	Any Obstructions?	N/A	N/A	Storm Grate/Utility Hazard?	N/A
	Obstruction Type			Storm Grate/Utility Type	
		N/A			N/A
		Yes		Surface Condition? (G/P)	Good

**Remove & Replace Curb Ramp With Two New Directional Ramps or Equivalent.**

**R304.2.2, R304.5.3**
