Access Compliance Report

Public Rights-of-Way

(Curb Ramps)

Intersection ID: 12220	Main Street: E_6TH_ST	Cross Street: N_COLLEGE_ST	Location: S
ADA ID: 83C750197386	Ramp Type: Perp	Initial Pass/Fail: Fail	Overall Compliance: No
Severity Score: 13.75			
Codes/Mitigation Info/Possible Solution		Field Measurements/Component Compliance

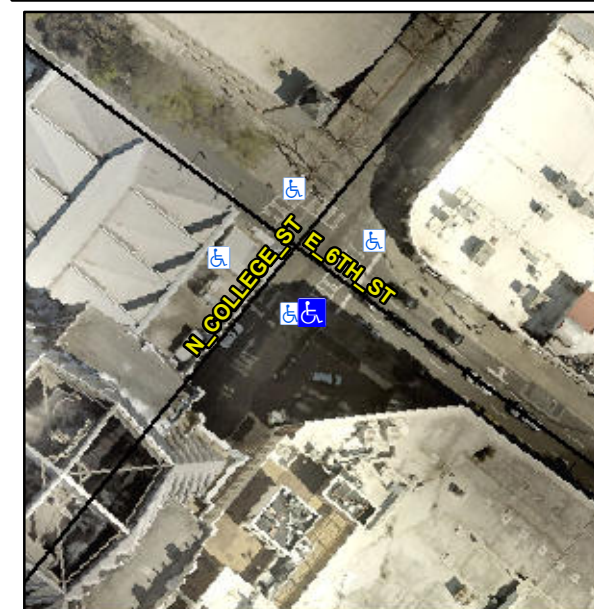
Not Found, R304.2.2, R304.5.3

Compliance	Description	Data	Compliance	Description	Data
N/A	Ramp Length (in)	72.0	No	Ramp Slope (%)	8.7
Yes	Ramp Width (in)	55.0	No	Ramp XSlope (%)	2.4
N/A	Flare Type LT	N/A	N/A	Flare Type RT	N/A
N/A	Flare Slope LT (%)	N/A	N/A	Flare Slope RT (%)	N/A
N/A	Flare Traversable LT?	N/A	N/A	Flare Traversable RT?	N/A
N/A	Landing Length (in)	N/A	N/A	DWS Provided?	N/A
N/A	Landing Width (in)	N/A	N/A	DWS Contrast?	N/A
N/A	Landing Slope (%)	N/A	N/A	DWS Length (in)	N/A
N/A	Landing X Slope (%)	N/A	N/A	DWS Full Width?	N/A
N/A	Landing Curb? (Y/N)	N/A	N/A	DWS Offset (in)	N/A
N/A	Shared Landing?	N/A			
N/A	Gutter Ponding?	N/A	N/A	Gutter Slope (%)	N/A
N/A	Gutter Lip Ht (in)	N/A	N/A	Gutter X Slope (%)	N/A
N/A	Painted X Walk1?	Yes	N/A	Painted X Walk2?	N/A
	X Walk 1 Direction	To NE		X Walk 2 Direction	N/A
N/A	X Walk 1 Width (in)	103.0	N/A	X Walk 2 Width (in)	N/A
	X Walk 1 Slope (%)	2.1		X Walk 2 Slope (%)	N/A
	X Walk 1 X Slope (%)	1.8		X Walk 2 X Slope (%)	N/A

N/A	Ramp inside XWalk1?	Yes	N/A	Ramp inside XWalk2?	N/A
	Road Slope (%)	N/A	N/A	Clear Space?	N/A
	Road X Slope (%)	N/A	N/A	Clear Space to XWalk (in)	N/A
N/A	Any Obstructions?	N/A	N/A	Storm Grate/Utility Hazard?	N/A
	Obstruction Type			Storm Grate/Utility Type	
		N/A			N/A
		Yes		Surface Condition? (G/P)	Good

Possible Solutions:

Remove & Replace Entire Ramp.
