Access Compliance Report Public Rights-of-Way (Curb Ramps)

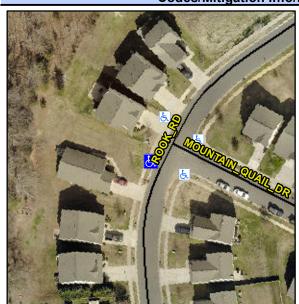
Intersection ID: 45553Main Street:MOUNTAIN_QUAIL_DRCross Street:ROOK_RDLocation:WADA ID: 83CA6CBA65B7Ramp Type:PerpInitial Pass/Fail:FailOverall Compliance:NoSeverity Score:21.25

Field Measurements/Component Compliance							
Comp	liance Description	Data	Comp	liance Description	Data		
N/A	Ramp Length (in)	47.5	No	Ramp Slope (%)	9.2		
No	Ramp Width (in)	47.5	Yes	Ramp XSlope (%)	1.8		
N/A	Flare Type LT	N/A	N/A	Flare Type RT	N/A		
N/A	Flare Slope LT (%)	N/A	N/A	Flare Slope RT (%)	N/A		
N/A	Flare Traversable LT?	N/A	N/A	Flare Traversable RT?	N/A		
N/A	Landing Length (in)	N/A	N/A	DWS Provided?	N/A		
N/A	Landing Width (in)	N/A	N/A	DWS Contrast?	N/A		
N/A	Landing Slope (%)	N/A	N/A	DWS Length (in)	N/A		
N/A	Landing X Slope (%)	N/A	N/A	DWS Full Width?	N/A		
N/A	Landing Curb? (Y/N)	N/A	N/A	DWS Offset (in)	N/A		
N/A	Shared Landing?	N/A					
N/A	Gutter Ponding?	N/A	N/A	Gutter Slope (%)	N/A		
N/A	Gutter Lip Ht (in)	N/A	N/A	Gutter X Slope (%)	N/A		
N/A	Painted X Walk1?	No	N/A	Painted X Walk2?	N/A		
	X Walk 1 Direction	To SE		X Walk 2 Direction	N/A		
N/A	X Walk 1 Width (in)	N/A	N/A	X Walk 2 Width (in)	N/A

X Walk 1 Slope (%)	3.4		X Walk 2 Slope (%)	N/A		
	X Walk 1 X Slope (%)	1.2		X Walk 2 X Slope (%)	N/A		
N/A	Ramp inside XWalk1?	N/A	N/A	Ramp inside XWalk2?	N/A		
	Road Slope (%)	N/A	N/A	Clear Space?	N/A		
	Road X Slope (%)	N/A	N/A	Clear Space to XWalk (in)	N/A		
N/A	Any Obstructions?	N/A	N/A	Storm Grate/Utility Hazard?	N/A		
	Obstruction Type			Storm Grate/Utility Type			
		N/A			N/A		
			Yes	Surface Condition? (G/P)	Good

Possible Solutions:					
Remove & Replace Entire Ramp.					
·					
Surveyor Notes:					
N/A					
PROW/ADA:					
Not Found, R304.5.1, R304.2.2
