Access Compliance Report

Public Rights-of-Way

(Curb Ramps)

Intersection ID: 42535	Main Street: BALTINGLASS_CT	Cross Street: CASTLETOWN_HOUSE_DR	Location: NE
ADA ID: 83DA84858D45	Ramp Type: BlendTrans1	Initial Pass/Fail: Fail	Overall Compliance: No
		Severity Score: 12.5

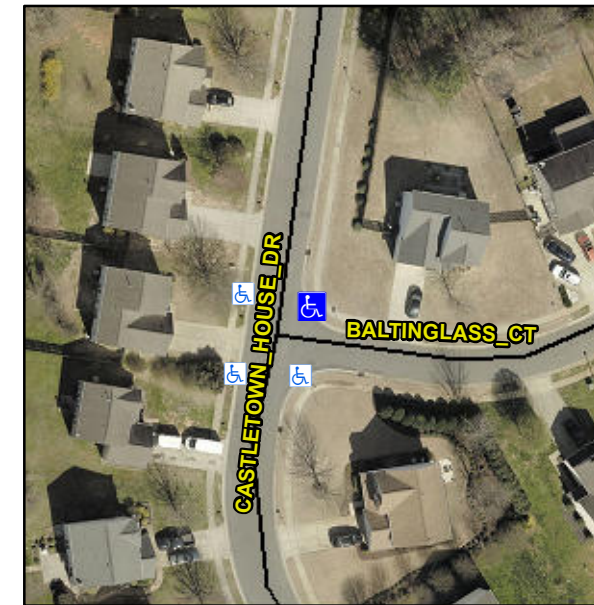
Compliance	Description	Data	Compliance	Description	Data
N/A	Ramp Length (in)	46.5	Yes	BlendTrans Slope (%)	3.6
Yes	Ramp Width (in)	49.0	No	BlendTrans XSlope (%)	5.1
N/A	Flare Type LT	N/A	N/A	Flare Type RT	N/A
N/A	Flare Slope LT (%)	N/A	N/A	Flare Slope RT (%)	N/A
N/A	Flare Traversable LT?	N/A	N/A	Flare Traversable RT?	N/A
N/A	Landing Length (in)	N/A	N/A	DWS Provided?	N/A
N/A	Landing Width (in)	N/A	N/A	DWS Contrast?	N/A
N/A	Landing Slope (%)	N/A	N/A	DWS Length (in)	N/A
N/A	Landing X Slope (%)	N/A	N/A	DWS Full Width?	N/A
N/A	Landing Curb? (Y/N)	N/A	N/A	DWS Offset (in)	N/A
N/A	Shared Landing?	N/A			
N/A	Gutter Ponding?	N/A	N/A	Gutter Slope (%)	N/A
N/A	Gutter Lip Ht (in)	N/A	N/A	Gutter X Slope (%)	N/A
N/A	Painted X Walk1?	No	N/A	Painted X Walk2?	No
	X Walk 1 Direction	To W		X Walk 2 Direction	To S
	X Walk 1 Width (in)	N/A		X Walk 2 Width (in)	N/A
	X Walk 1 Slope (%)	5.0		X Walk 2 Slope (%)	2.9
	X Walk 1 X Slope (%)	3.8		X Walk 2 X Slope (%)	3.3

N/A	Ramp inside XWalk1?	N/A	N/A	Ramp inside XWalk2?	N/A
	Road Slope (%)	3.8		Clear Space?	N/A
	Road X Slope (%)	6.2	N/A	Clear Space to XWalk (in)	N/A
N/A	Any Obstructions?	N/A	N/A	Storm Grate/Utility Hazard?	N/A
	Obstruction Type			Storm Grate/Utility Type	
		N/A			N/A
			Yes	Surface Condition? (G/P)	Good
			No	Curb Slope (%)	7.6

Remove & Replace Curb Ramp With Two New Directional Ramps or Equivalent.
