Access Compliance Report

Public Rights-of-Way

(Curb Ramps)

Intersection ID: 12975	Main Street: HICKORY GROVE RD	Cross Street: HOBBS HILL DR	Location: SW
ADA ID: 83E28A7754FA	Ramp Type: PerpDiag	Initial Pass/Fail: Fail	Overall Compliance: No
Severity Score: 21.25			
Codes/Mitigation Info/Possible Solution		Field Measurements/Component Compliance

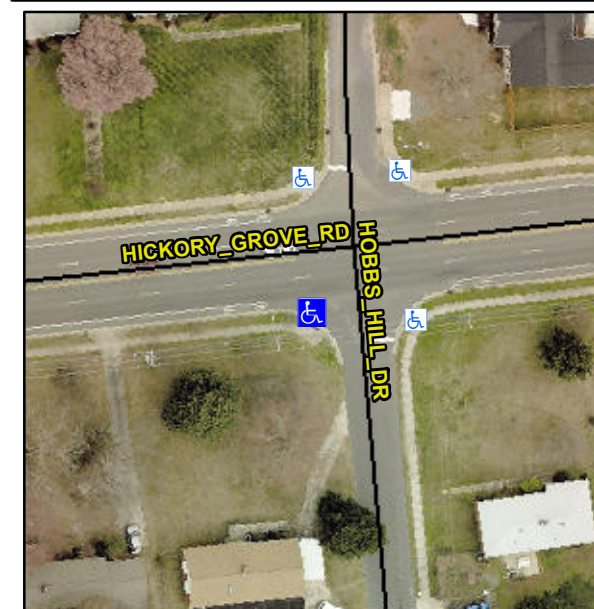
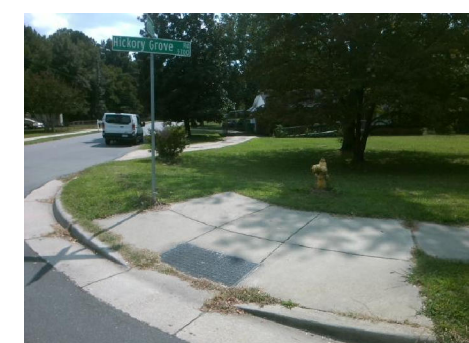
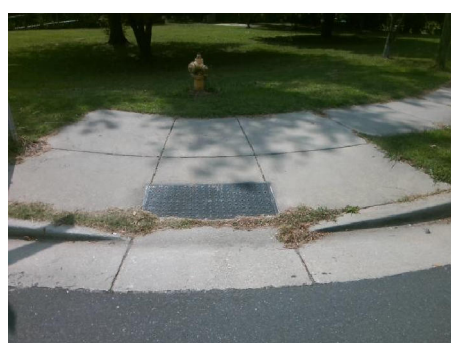
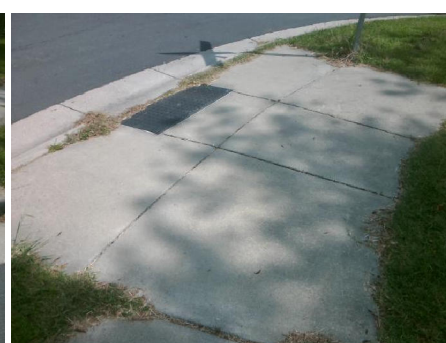
Not Found, R304.5.1, R304.2.2

Compliance	Description	Data	Compliance	Description	Data
N/A	Ramp Length (in)	48.0	No	Ramp Slope (%)	8.4
No	Ramp Width (in)	41.5	Yes	Ramp XSlope (%)	0.2
N/A	Flare Type LT	N/A	N/A	Flare Type RT	N/A
N/A	Flare Slope LT (%)	N/A	N/A	Flare Slope RT (%)	N/A
N/A	Flare Traversable LT?	N/A	N/A	Flare Traversable RT?	N/A
N/A	Landing Length (in)	N/A	N/A	DWS Provided?	N/A
N/A	Landing Width (in)	N/A	N/A	DWS Contrast?	N/A
N/A	Landing Slope (%)	N/A	N/A	DWS Length (in)	N/A
N/A	Landing X Slope (%)	N/A	N/A	DWS Full Width?	N/A
N/A	Landing Curb? (Y/N)	N/A	N/A	DWS Offset (in)	N/A
N/A	Shared Landing?	N/A			
N/A	Gutter Ponding?	N/A	N/A	Gutter Slope (%)	N/A
N/A	Gutter Lip Ht (in)	N/A	N/A	Gutter X Slope (%)	N/A
N/A	Painted X Walk1?	No	N/A	Painted X Walk2?	No
	X Walk 1 Direction	To E		X Walk 2 Direction	To N
N/A	X Walk 1 Width (in)	N/A	N/A	X Walk 2 Width (in)	N/A
	X Walk 1 Slope (%)	4.0		X Walk 2 Slope (%)	1.0
	X Walk 1 X Slope (%)	1.8		X Walk 2 X Slope (%)	2.2

N/A	Ramp inside XWalk1?	N/A	N/A	Ramp inside XWalk2?	N/A
	Road Slope (%)	0.1	N/A	Clear Space?	N/A
	Road X Slope (%)	3.4	N/A	Clear Space to XWalk (in)	N/A
N/A	Any Obstructions?	N/A	N/A	Storm Grate/Utility Hazard?	N/A
	Obstruction Type			Storm Grate/Utility Type	
		N/A			N/A
		Yes		Surface Condition? (G/P)	Good

Possible Solutions:

Remove & Replace Curb Ramp With Two New Directional Ramps or Equivalent.
