Access Compliance Report

Public Rights-of-Way

(Curb Ramps)

Intersection ID: 13994	Main Street: E_3RD_ST	Cross Street: S_TORRENCE_ST	Location: W
ADA ID: 83ECE922E968	Ramp Type: PerpDiag	Initial Pass/Fail: Fail	Overall Compliance: No
		Severity Score: 30

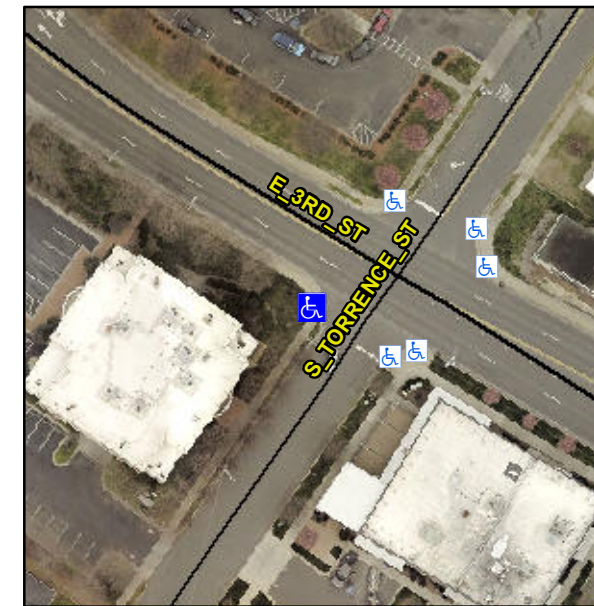
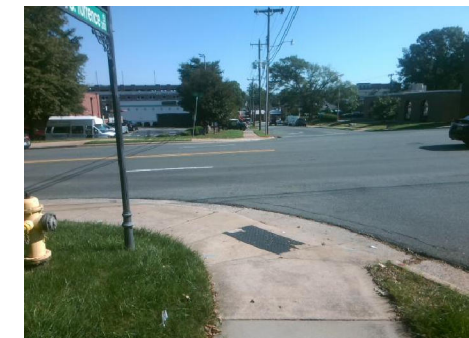
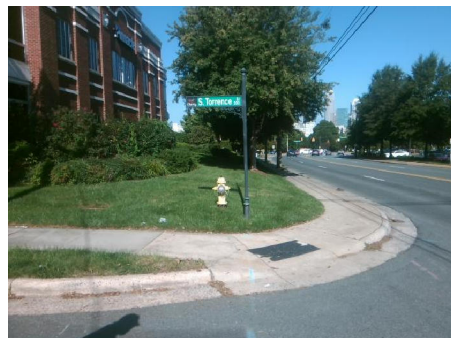
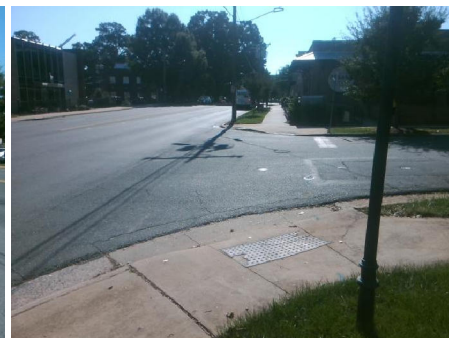
Not Found, R304.5.1, R304.5.3

Compliance	Description	Data	Compliance	Description	Data
N/A	Ramp Length (in)	74.0	Yes	Ramp Slope (%)	5.2
No	Ramp Width (in)	33.0	No	Ramp XSlope (%)	6.3
N/A	Flare Type LT	N/A	N/A	Flare Type RT	N/A
N/A	Flare Slope LT (%)	N/A	N/A	Flare Slope RT (%)	N/A
N/A	Flare Traversable LT?	N/A	N/A	Flare Traversable RT?	N/A
N/A	Landing Length (in)	N/A	N/A	DWS Provided?	N/A
N/A	Landing Width (in)	N/A	N/A	DWS Contrast?	N/A
N/A	Landing Slope (%)	N/A	N/A	DWS Length (in)	N/A
N/A	Landing X Slope (%)	N/A	N/A	DWS Full Width?	N/A
N/A	Landing Curb? (Y/N)	N/A	N/A	DWS Offset (in)	N/A
N/A	Shared Landing?	N/A			
N/A	Gutter Ponding?	N/A	N/A	Gutter Slope (%)	N/A
N/A	Gutter Lip Ht (in)	1.0	N/A	Gutter X Slope (%)	N/A
N/A	Painted X Walk1?	No	N/A	Painted X Walk2?	No
	X Walk 1 Direction	To SE		X Walk 2 Direction	To NE
N/A	X Walk 1 Width (in)	N/A	N/A	X Walk 2 Width (in)	N/A
	X Walk 1 Slope (%)	7.3		X Walk 2 Slope (%)	3.5
	X Walk 1 X Slope (%)	2.6		X Walk 2 X Slope (%)	1.0

N/A	Ramp inside XWalk1?	N/A	N/A	Ramp inside XWalk2?	N/A
	Road Slope (%)	5.0	N/A	Clear Space?	N/A
	Road X Slope (%)	3.1	N/A	Clear Space to XWalk (in)	N/A
N/A	Any Obstructions?	N/A	N/A	Storm Grate/Utility Hazard?	N/A
	Obstruction Type			Storm Grate/Utility Type	
		N/A			N/A
			Yes	Surface Condition? (G/P)	Good

Remove & Replace Curb Ramp With Two New Directional Ramps or Equivalent.
