## Access Compliance Report Public Rights-of-Way (Curb Ramps)

Intersection ID: 12170 Main Street: S\_POPLAR\_ST Cross Street: W\_4TH\_ST Location: N

ADA ID: 83EE530B67A4 Ramp Type: PerpDiag Initial Pass/Fail: Pass Overall Compliance: No Severity Score: 0

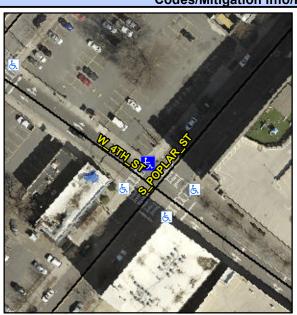
Street 1 Name W 4TH ST
Stop Condition-Street 2 Signal
Street 2 Name S POPLAR ST
Stop Condition-Street 1 Signal

Field Measurements/Component Compliance					
Compliance Description Da		Data	Comp	oliance Description	Data
N/A	Ramp Length (in)	70.0	Yes	Ramp Slope (%)	6.3
Yes	Ramp Width (in)	48.0	Yes	Ramp XSlope (%)	1.1
N/A	Flare Type LT	Sloped	N/A	Flare Type RT	N/A
N/A	Flare Slope LT (%)	2.6	Yes	Flare Slope RT (%)	8.5
N/A	Flare Traversable LT?	Yes	N/A	Flare Traversable RT?	Yes
No	Landing Length (in)	34.0	Yes	DWS Provided?	Yes
Yes	Landing Width (in)	54.0	Yes	DWS Contrast?	Yes
No	Landing Slope (%)	4.3	Yes	DWS Length (in)	24.0
No	Landing X Slope (%)	3.7	Yes	DWS Full Width?	Yes
N/A	Landing Curb? (Y/N)	No	No	DWS Offset (in)	6.0
N/A	Shared Landing?	No			
Yes	Gutter Ponding?	No	Yes	Gutter Slope (%)	2.2
Yes	Gutter Lip Ht (in)	0.0	Yes	Gutter X Slope (%)	0.8
N/A	Painted X Walk1?	Yes	N/A	Painted X Walk2?	Yes
	X Walk 1 Direction	To SW		X Walk 2 Direction	To SE
N/A	X Walk 1 Width (in)	112.0	N/A	X Walk 2 Width (in)	113.0
	X Walk 1 Slope (%)	0.7		X Walk 2 Slope (%)	0.3

X Walk 1 X Slope (%)	2.1		X Walk 2 X Slope (%)	0.8
Yes	Ramp inside XWalk1?	Yes	Yes	Ramp inside XWalk2?	Yes
	Road Slope (%)	2.2	N/A	Clear Space?	Yes
	Road X Slope (%)	0.9	Yes	Clear Space to XWalk (in)	93.0
Yes	Any Obstructions?	No	Yes	Storm Grate/Utility Hazard?	No
	Obstruction Type		Į.	Storm Grate/Utility Type	
		N/A			N/A
			Yes	Surface Condition? (G/P)	Good

Remove & Replace Curb Ramp With Two New Directional Ramps or Equivalent.

R304.2.1, R304.2.2-Perp, R304.3.2-Para, R304.5.3, R305.2
