Access Compliance Report

Public Rights-of-Way

(Curb Ramps)

Intersection ID: 10026347	Main Street: FAIRWOOD_AV	Cross Street: N/A	Location:	N
ADA ID: 83F3FD3542CE	Ramp Type: Perp	Initial Pass/Fail: Pass	Overall Compliance: Yes	Severity Score: 0
Codes/Mitigation Info/Possible Solution		Field Measurements/Component Compliance

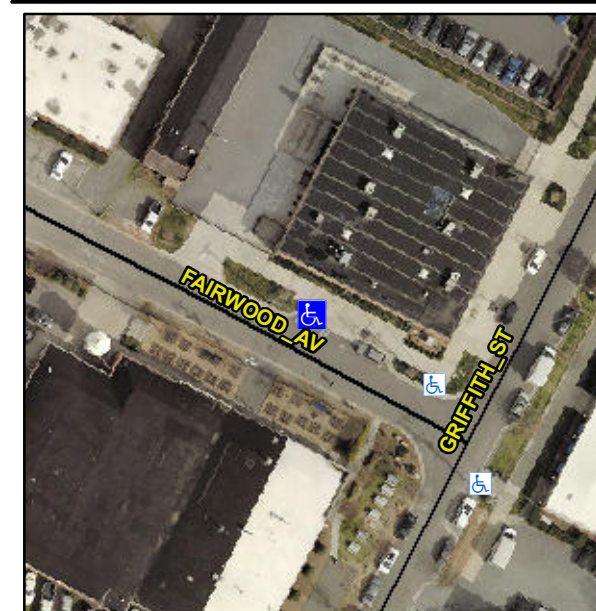
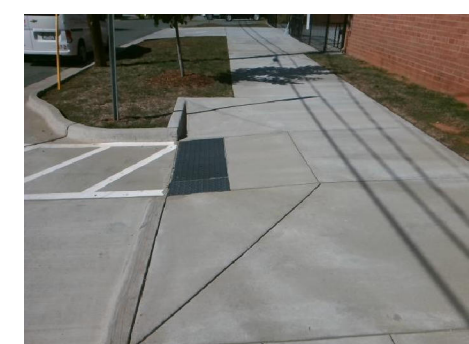
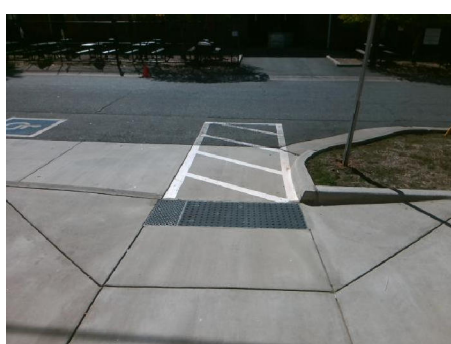
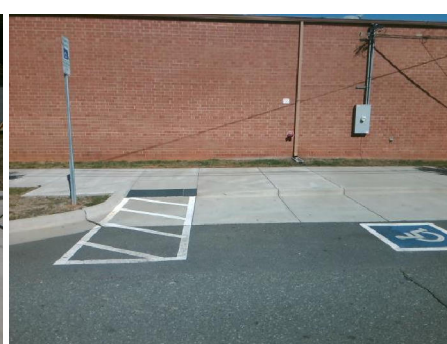
Compliance	Description	Data	Compliance	Description	Data
N/A	Ramp Length (in)	60.0	Yes	Ramp Slope (%)	7.3
Yes	Ramp Width (in)	60.0	Yes	Ramp XSlope (%)	0.8
N/A	Flare Type LT	Sloped	N/A	Flare Type RT	N/A
N/A	Flare Slope LT (%)	4.5	Yes	Flare Slope RT (%)	7.2
N/A	Flare Traversable LT?	Yes	N/A	Flare Traversable RT?	Yes
Yes	Landing Length (in)	73.0	Yes	DWS Provided?	Yes
Yes	Landing Width (in)	63.0	Yes	DWS Contrast?	Yes
Yes	Landing Slope (%)	1.9	Yes	DWS Length (in)	24.0
Yes	Landing X Slope (%)	0.8	Yes	DWS Full Width?	Yes
N/A	Landing Curb? (Y/N)	No	Yes	DWS Offset (in)	0.5
N/A	Shared Landing?	No			
Yes	Gutter Ponding?	No	Yes	Gutter Slope (%)	2.4
Yes	Gutter Lip Ht (in)	0.0	Yes	Gutter X Slope (%)	1.3
N/A	Painted X Walk1?	No	N/A	Painted X Walk2?	N/A
	X Walk 1 Direction	To S		X Walk 2 Direction	N/A
N/A	X Walk 1 Width (in)	N/A	N/A	X Walk 2 Width (in)	N/A
	X Walk 1 Slope (%)	0.6		X Walk 2 Slope (%)	N/A
	X Walk 1 X Slope (%)	1.3		X Walk 2 X Slope (%)	N/A

N/A	Ramp inside XWalk1?	N/A	N/A	Ramp inside XWalk2?	N/A
	Road Slope (%)	N/A	N/A	Clear Space?	Yes
	Road X Slope (%)	N/A	N/A	Clear Space to XWalk (in)	N/A
Yes	Any Obstructions?	No	Yes	Storm Grate/Utility Hazard?	No
	Obstruction Type			Storm Grate/Utility Type	
			N/A		N/A
			Yes	Surface Condition? (G/P)	Good

Possible Solutions:

N/A
