# Access Compliance Report

## Public Rights-of-Way

### (Curb Ramps)

| Intersection ID: 8305 | Main Street: FREEDOM_DR | Cross Street: PARK_FAIRFAX_DR | Location: NW |

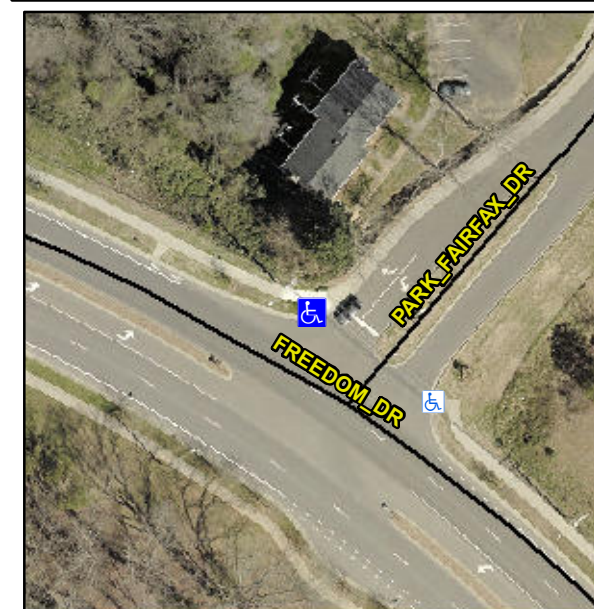
**Not Found, R304.5.3, R305.2**

| Compliance | Description | Data | Compliance | Description | Data |
|---|---|---|---|---|---|
| Yes | Ramp Width (in) | 48.0 | No | Ramp XSlope (%) | 4.2 |
| N/A | Landing Curb? (Y/N) | No | No | DWS Offset (in) | 3.5 |
| Yes | Gutter Lip Ht (in) | 0.0 | No | Gutter X Slope (%) | 4.8 |

**Remove & Replace Curb Ramp With Two New Directional Ramps or Equivalent. Remove & Replace Gutter.**

Total Cost: \$ 3950.00
