Access Compliance Report

Public Rights-of-Way

(Curb Ramps)

Intersection ID: 42683	Main Street: BROOKWOOD_RD	Cross Street: SHARON_RD	Location: SE
ADA ID: 840D2323E378	Ramp Type: Perp	Initial Pass/Fail: Fail	Overall Compliance: No
Codes/Mitigation Info/Possible Solution			Severity Score: 25
			Field Measurements/Component Compliance

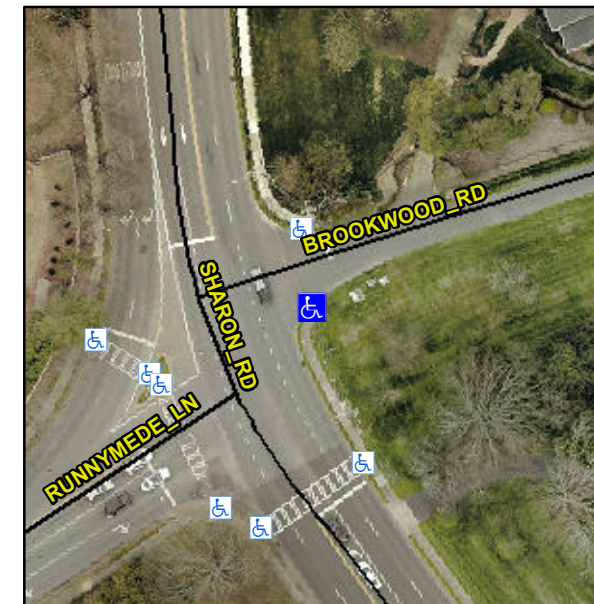
Not Found, R304.2.2

Compliance	Description	Data	Compliance	Description	Data
N/A	Ramp Length (in)	62.0	No	Ramp Slope (%)	14.7
Yes	Ramp Width (in)	48.0	Yes	Ramp XSlope (%)	0.7
N/A	Flare Type LT	N/A	N/A	Flare Type RT	N/A
N/A	Flare Slope LT (%)	N/A	N/A	Flare Slope RT (%)	N/A
N/A	Flare Traversable LT?	N/A	N/A	Flare Traversable RT?	N/A
N/A	Landing Length (in)	N/A	N/A	DWS Provided?	N/A
N/A	Landing Width (in)	N/A	N/A	DWS Contrast?	N/A
N/A	Landing Slope (%)	N/A	N/A	DWS Length (in)	N/A
N/A	Landing X Slope (%)	N/A	N/A	DWS Full Width?	N/A
N/A	Landing Curb? (Y/N)	N/A	N/A	DWS Offset (in)	N/A
N/A	Shared Landing?	N/A			
N/A	Gutter Ponding?	N/A	N/A	Gutter Slope (%)	N/A
N/A	Gutter Lip Ht (in)	N/A	N/A	Gutter X Slope (%)	N/A
N/A	Painted X Walk1?	No	N/A	Painted X Walk2?	N/A
	X Walk 1 Direction	To N		X Walk 2 Direction	N/A
N/A	X Walk 1 Width (in)	N/A	N/A	X Walk 2 Width (in)	N/A
	X Walk 1 Slope (%)	3.4		X Walk 2 Slope (%)	N/A
	X Walk 1 X Slope (%)	3.3		X Walk 2 X Slope (%)	N/A

N/A	Ramp inside XWalk1?	N/A	N/A	Ramp inside XWalk2?	N/A
	Road Slope (%)	N/A	N/A	Clear Space?	N/A
	Road X Slope (%)	N/A	N/A	Clear Space to XWalk (in)	N/A
N/A	Any Obstructions?	N/A	N/A	Storm Grate/Utility Hazard?	N/A
	Obstruction Type			Storm Grate/Utility Type	
		N/A			N/A
			Yes	Surface Condition? (G/P)	Good

Possible Solutions:

Remove & Replace Entire Ramp.
