# Access Compliance Report

## Public Rights-of-Way

### (Curb Ramps)

Intersection ID: 49251	Main Street: RIDGE_PATH_LN	Cross Street: PROSPERITY_RIDGE_RD	Location: E
ADA ID: 841716B799A3	Ramp Type: BlendTrans1	Initial Pass/Fail: Fail	Overall Compliance: No
Severity Score: 8.75			
Codes/Mitigation Info/Possible Solution		Field Measurements/Component Compliance

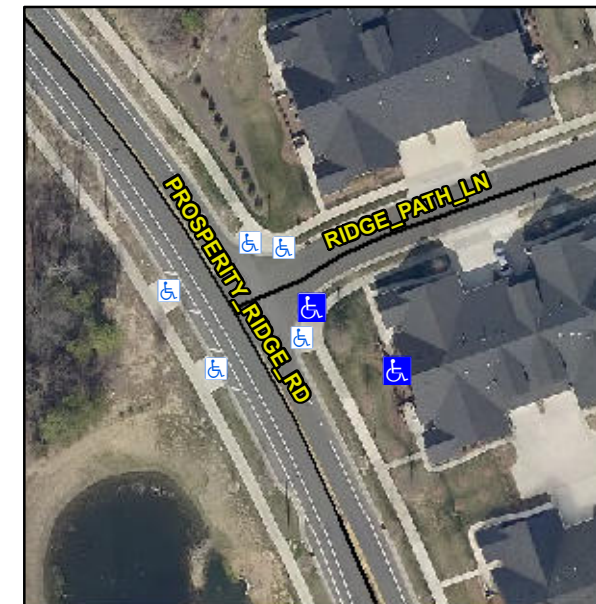
**LNDG LIP 0.5**

**Not Found, R304.5.1**

Compliance	Description	Data	Compliance	Description	Data
N/A	Ramp Length (in)	59.0	Yes	BlendTrans Slope (%)	3.6
No	Ramp Width (in)	47.5	Yes	BlendTrans XSlope (%)	0.3
N/A	Flare Type LT	N/A	N/A	Flare Type RT	N/A
N/A	Flare Slope LT (%)	N/A	N/A	Flare Slope RT (%)	N/A
N/A	Flare Traversable LT?	N/A	N/A	Flare Traversable RT?	N/A
N/A	Landing Length (in)	N/A	N/A	DWS Provided?	N/A
N/A	Landing Width (in)	N/A	N/A	DWS Contrast?	N/A
N/A	Landing Slope (%)	N/A	N/A	DWS Length (in)	N/A
N/A	Landing X Slope (%)	N/A	N/A	DWS Full Width?	N/A
N/A	Landing Curb? (Y/N)	N/A	N/A	DWS Offset (in)	N/A
N/A	Shared Landing?	N/A			
N/A	Gutter Ponding?	N/A	N/A	Gutter Slope (%)	N/A
N/A	Gutter Lip Ht (in)	1.0	N/A	Gutter X Slope (%)	N/A
N/A	Painted X Walk1?	No	N/A	Painted X Walk2?	N/A
	X Walk 1 Direction	To NW		X Walk 2 Direction	N/A
	X Walk 1 Width (in)	N/A		X Walk 2 Width (in)	N/A
	X Walk 1 Slope (%)	3.6		X Walk 2 Slope (%)	N/A
	X Walk 1 X Slope (%)	0.4		X Walk 2 X Slope (%)	N/A

N/A	Ramp inside XWalk1?	N/A	N/A	Ramp inside XWalk2?	N/A
	Road Slope (%)	0.4		Clear Space?	N/A
	Road X Slope (%)	3.6	N/A	Clear Space to XWalk (in)	N/A
N/A	Any Obstructions?	N/A	N/A	Storm Grate/Utility Hazard?	N/A
	Obstruction Type			Storm Grate/Utility Type	
		N/A			N/A
			Yes	Surface Condition? (G/P)	Good
			No	Curb Slope (%)	11.0

**Remove & Replace Curb Ramp With Two New Directional Ramps or Equivalent.**
