Access Compliance Report

Public Rights-of-Way

(Curb Ramps)

Intersection ID: 9909	Main Street: PLOTT_RD	Cross Street: STRAWBERRY_POINT_DR	Location: SW
ADA ID: 8429E83833B0	Ramp Type: PerpDiag	Initial Pass/Fail: Fail	Overall Compliance: No
			Severity Score: 46.25

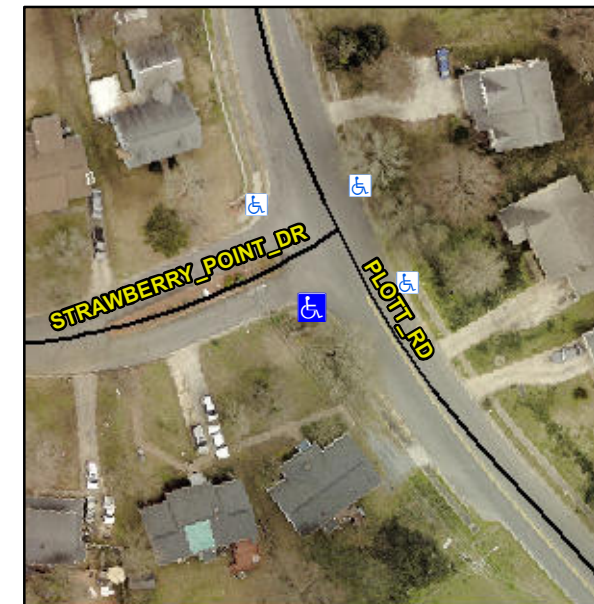
Not Found, R304.5.1, R304.2.2, R304.5.3

Compliance	Description	Data	Compliance	Description	Data
N/A	Ramp Length (in)	64.0	No	Ramp Slope (%)	10.5
No	Ramp Width (in)	43.5	No	Ramp XSlope (%)	9.1
N/A	Flare Type LT	N/A	N/A	Flare Type RT	N/A
N/A	Flare Slope LT (%)	N/A	N/A	Flare Slope RT (%)	N/A
N/A	Flare Traversable LT?	N/A	N/A	Flare Traversable RT?	N/A
N/A	Landing Length (in)	N/A	N/A	DWS Provided?	N/A
N/A	Landing Width (in)	N/A	N/A	DWS Contrast?	N/A
N/A	Landing Slope (%)	N/A	N/A	DWS Length (in)	N/A
N/A	Landing X Slope (%)	N/A	N/A	DWS Full Width?	N/A
N/A	Landing Curb? (Y/N)	N/A	N/A	DWS Offset (in)	N/A
N/A	Shared Landing?	N/A			
N/A	Gutter Ponding?	N/A	N/A	Gutter Slope (%)	N/A
N/A	Gutter Lip Ht (in)	N/A	N/A	Gutter X Slope (%)	N/A
N/A	Painted X Walk1?	No	N/A	Painted X Walk2?	No
	X Walk 1 Direction	To E		X Walk 2 Direction	To N
N/A	X Walk 1 Width (in)	N/A	N/A	X Walk 2 Width (in)	N/A
	X Walk 1 Slope (%)	6.5		X Walk 2 Slope (%)	4.1
	X Walk 1 X Slope (%)	4.2		X Walk 2 X Slope (%)	6.7

N/A	Ramp inside XWalk1?	N/A	N/A	Ramp inside XWalk2?	N/A
	Road Slope (%)	8.5	N/A	Clear Space?	N/A
	Road X Slope (%)	1.3	N/A	Clear Space to XWalk (in)	N/A
N/A	Any Obstructions?	N/A	N/A	Storm Grate/Utility Hazard?	N/A
	Obstruction Type			Storm Grate/Utility Type	
		N/A			N/A
			Yes	Surface Condition? (G/P)	Good

Remove & Replace Curb Ramp With Two New Directional Ramps or Equivalent.

Total Cost: \$ 3200.00
