Access Compliance Report

Public Rights-of-Way

(Curb Ramps)

Intersection ID: 18632	Main Street: ROCKBROOK_DR	Cross Street: RUNNYMEDE_LN	Location: NE
ADA ID: 84322548BA3D	Ramp Type: PerpDiag	Initial Pass/Fail: Fail	Overall Compliance: No
Codes/Mitigation Info/Possible Solution		Field Measurements/Component Compliance	
Severity Score: 21.25

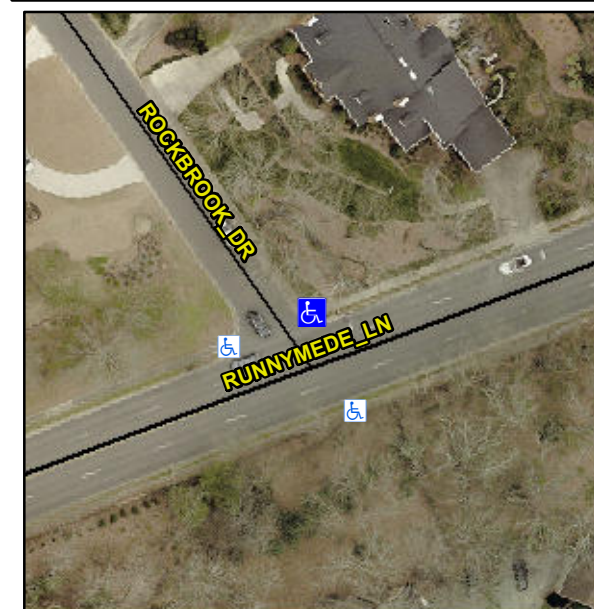
Not Found, R304.5.1, R304.5.3

Compliance	Description	Data	Compliance	Description	Data
N/A	Ramp Length (in)	62.0	Yes	Ramp Slope (%)	6.1
No	Ramp Width (in)	36.0	No	Ramp XSlope (%)	5.6
N/A	Flare Type LT	N/A	N/A	Flare Type RT	N/A
N/A	Flare Slope LT (%)	N/A	N/A	Flare Slope RT (%)	N/A
N/A	Flare Traversable LT?	N/A	N/A	Flare Traversable RT?	N/A
N/A	Landing Length (in)	N/A	N/A	DWS Provided?	N/A
N/A	Landing Width (in)	N/A	N/A	DWS Contrast?	N/A
N/A	Landing Slope (%)	N/A	N/A	DWS Length (in)	N/A
N/A	Landing X Slope (%)	N/A	N/A	DWS Full Width?	N/A
N/A	Landing Curb? (Y/N)	N/A	N/A	DWS Offset (in)	N/A
N/A	Shared Landing?	N/A			
N/A	Gutter Ponding?	N/A	N/A	Gutter Slope (%)	N/A
N/A	Gutter Lip Ht (in)	N/A	N/A	Gutter X Slope (%)	N/A
N/A	Painted X Walk1?	No	N/A	Painted X Walk2?	No
	X Walk 1 Direction	To SW		X Walk 2 Direction	To SE
N/A	X Walk 1 Width (in)	N/A	N/A	X Walk 2 Width (in)	N/A
	X Walk 1 Slope (%)	5.3		X Walk 2 Slope (%)	11.3
	X Walk 1 X Slope (%)	8.0		X Walk 2 X Slope (%)	3.2

N/A	Ramp inside XWalk1?	N/A	N/A	Ramp inside XWalk2?	N/A
	Road Slope (%)	3.6	N/A	Clear Space?	N/A
	Road X Slope (%)	11.3	N/A	Clear Space to XWalk (in)	N/A
N/A	Any Obstructions?	N/A	N/A	Storm Grate/Utility Hazard?	N/A
	Obstruction Type			Storm Grate/Utility Type	
		N/A			N/A
			Yes	Surface Condition? (G/P)	Good

Remove & Replace Curb Ramp With Two New Directional Ramps or Equivalent.
