Access Compliance Report

Public Rights-of-Way

(Curb Ramps)

Intersection ID: 10053	Main Street: BURTON_ST	Cross Street: FONTANA_AV	Location: SE
ADA ID: 84322F74BFA1	Ramp Type: Perp	Initial Pass/Fail: Fail	Overall Compliance: No
		Severity Score: 12.5

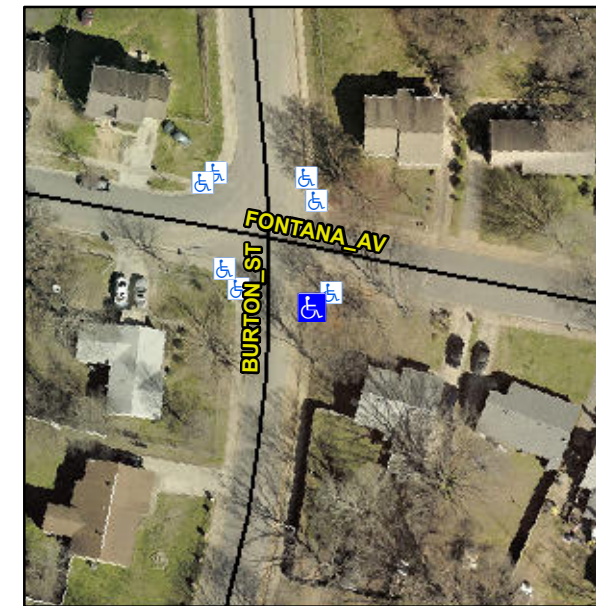
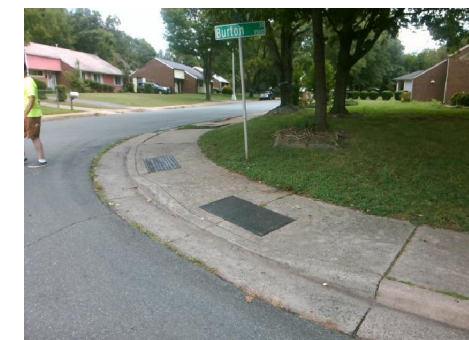
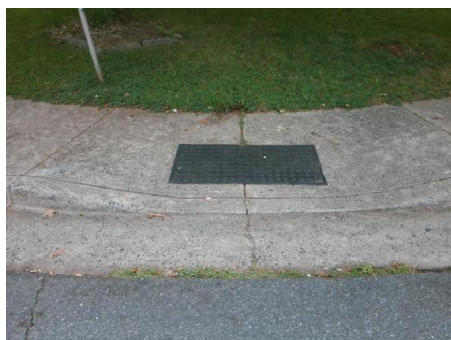
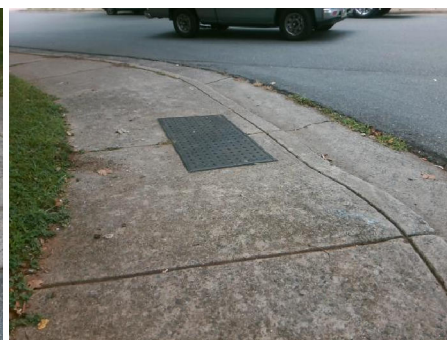
Not Found, R304.5.3

Compliance	Description	Data	Compliance	Description	Data
N/A	Ramp Length (in)	60.0	Yes	Ramp Slope (%)	5.8
Yes	Ramp Width (in)	48.0	No	Ramp XSlope (%)	6.7
N/A	Flare Type LT	N/A	N/A	Flare Type RT	N/A
N/A	Flare Slope LT (%)	N/A	N/A	Flare Slope RT (%)	N/A
N/A	Flare Traversable LT?	N/A	N/A	Flare Traversable RT?	N/A
N/A	Landing Length (in)	N/A	N/A	DWS Provided?	N/A
N/A	Landing Width (in)	N/A	N/A	DWS Contrast?	N/A
N/A	Landing Slope (%)	N/A	N/A	DWS Length (in)	N/A
N/A	Landing X Slope (%)	N/A	N/A	DWS Full Width?	N/A
N/A	Landing Curb? (Y/N)	N/A	N/A	DWS Offset (in)	N/A
N/A	Shared Landing?	N/A			
N/A	Gutter Ponding?	N/A	N/A	Gutter Slope (%)	N/A
N/A	Gutter Lip Ht (in)	2.0	N/A	Gutter X Slope (%)	N/A
N/A	Painted X Walk1?	No	N/A	Painted X Walk2?	N/A
	X Walk 1 Direction	To NW		X Walk 2 Direction	N/A
N/A	X Walk 1 Width (in)	N/A	N/A	X Walk 2 Width (in)	N/A
	X Walk 1 Slope (%)	2.4		X Walk 2 Slope (%)	N/A
	X Walk 1 X Slope (%)	2.8		X Walk 2 X Slope (%)	N/A

Remove & Replace Entire Ramp.
