# Access Compliance Report

## Public Rights-of-Way

| Intersection ID: 16040 | Main Street: GREYSTONE_RD | Cross Street: MAYFIELD_AV | Location: NE |
| ADA ID: 8441EE453E9C | Ramp Type: PerpDiag | Initial Pass/Fail: Pass | Overall Compliance: No |

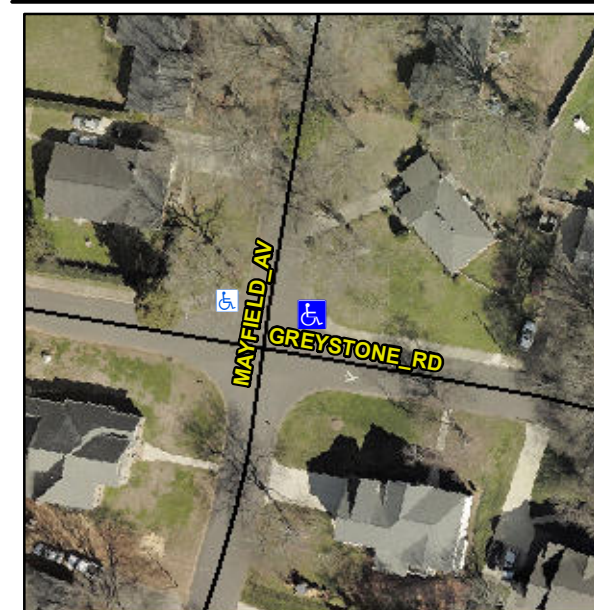
**Not Found, R304.5.3, R304.2.1, R304.2.2-Perp, R304.3.2-Para, R305.2**

| Compliance | Description | Data | Compliance | Description | Data |
|---|---|---|---|---|---|
| Yes | Ramp Width (in) | 48.0 | No | Ramp XSlope (%) | 4.6 |
| No | Landing Length (in) | N/A | Yes | DWS Provided? | Yes |
| No | Landing Width (in) | N/A | Yes | DWS Contrast? | Yes |
| No | Landing Slope (%) | N/A | Yes | DWS Length (in) | 24.5 |
| No | Landing X Slope (%) | N/A | Yes | DWS Full Width? | Yes |
| N/A | Landing Curb? (Y/N) | No | No | DWS Offset (in) | 3.5 |

**Remove & Replace Curb Ramp With Two New Directional Ramps or Equivalent.**
