Access Compliance Report

Public Rights-of-Way

(Curb Ramps)

Intersection ID: N/A	Main Street: S BREVARD ST	Cross Street: E 4TH ST	Location:	N
ADA ID: 84494F1050F3	Ramp Type: Perp	Initial Pass/Fail: Fail	Overall Compliance: No	Severity Score: 10
Codes/Mitigation Info/Possible Solution		Field Measurements/Component Compliance

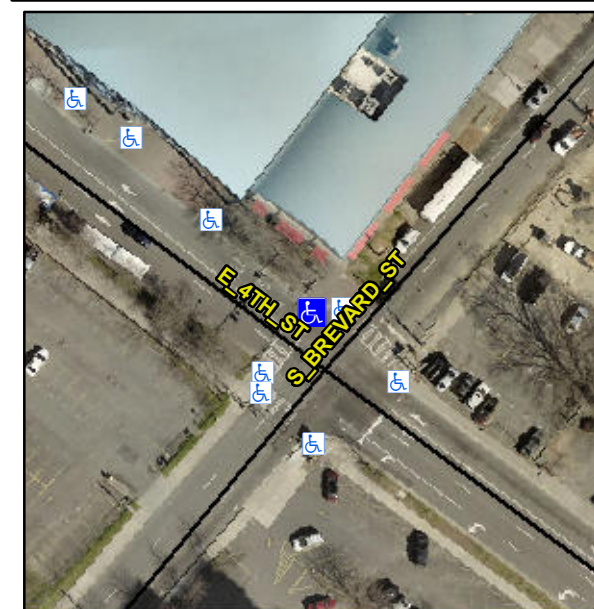
R304.5.1, R304.5.3

Compliance	Description	Data	Compliance	Description	Data
N/A	Ramp Length (in)	40.0	Yes	Ramp Slope (%)	7.0
No	Ramp Width (in)	47.0	No	Ramp XSlope (%)	3.9
N/A	Flare Type LT	N/A	N/A	Flare Type RT	N/A
N/A	Flare Slope LT (%)	N/A	N/A	Flare Slope RT (%)	N/A
N/A	Flare Traversable LT?	No	N/A	Flare Traversable RT?	No
N/A	Landing Length (in)	N/A	N/A	DWS Provided?	N/A
N/A	Landing Width (in)	N/A	N/A	DWS Contrast?	N/A
N/A	Landing Slope (%)	N/A	N/A	DWS Length (in)	N/A
N/A	Landing X Slope (%)	N/A	N/A	DWS Full Width?	N/A
N/A	Landing Curb? (Y/N)	N/A	N/A	DWS Offset (in)	N/A
N/A	Shared Landing?	N/A			
N/A	Gutter Ponding?	N/A	N/A	Gutter Slope (%)	N/A
N/A	Gutter Lip Ht (in)	N/A	N/A	Gutter X Slope (%)	N/A
N/A	Painted X Walk1?	Yes	N/A	Painted X Walk2?	N/A
	X Walk 1 Direction	To SW		X Walk 2 Direction	N/A
N/A	X Walk 1 Width (in)	111.0	N/A	X Walk 2 Width (in)	N/A
	X Walk 1 Slope (%)	3.2		X Walk 2 Slope (%)	N/A
	X Walk 1 X Slope (%)	2.8		X Walk 2 X Slope (%)	N/A

N/A	Ramp inside XWalk1?	Yes	N/A	Ramp inside XWalk2?	N/A
	Road Slope (%)	N/A	N/A	Clear Space?	N/A
	Road X Slope (%)	N/A	N/A	Clear Space to XWalk (in)	N/A
N/A	Any Obstructions?	N/A	N/A	Storm Grate/Utility Hazard?	N/A
	Obstruction Type			Storm Grate/Utility Type	
		N/A			N/A
			Yes	Surface Condition? (G/P)	Good

Possible Solutions:

Remove & Replace Entire Ramp.
