Access Compliance Report

Public Rights-of-Way

(Curb Ramps)

Intersection ID: 52172	Main Street: BEARLING_WY	Cross Street: AVERY_MEADOWS_DR	Location: NE
ADA ID: 844F7AF1BEEC	Ramp Type: Perp	Initial Pass/Fail: Fail	Overall Compliance: No
Severity Score: 10			
Codes/Mitigation Info/Possible Solution		Field Measurements/Component Compliance

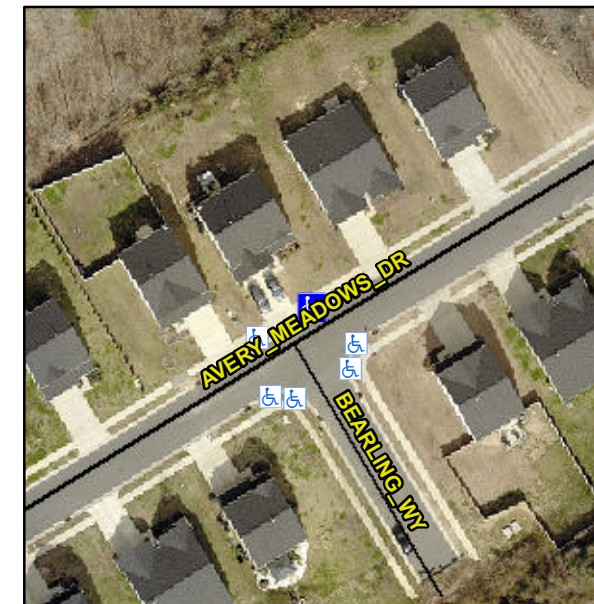
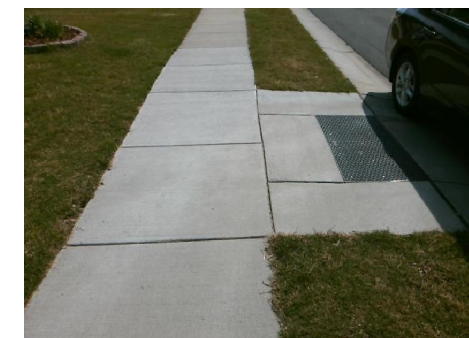
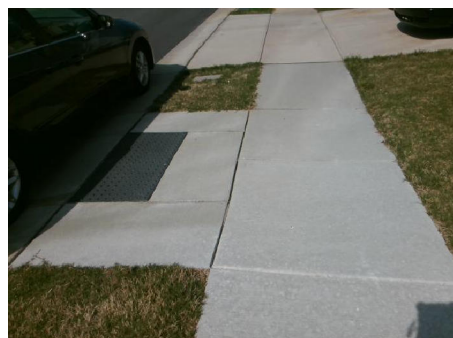
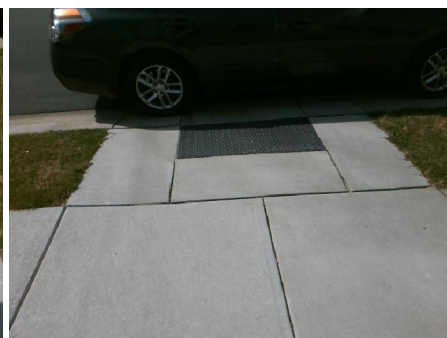
Not Found, R304.5.1

Compliance	Description	Data	Compliance	Description	Data
N/A	Ramp Length (in)	47.5	Yes	Ramp Slope (%)	6.8
No	Ramp Width (in)	47.5	Yes	Ramp XSlope (%)	2.2
N/A	Flare Type LT	N/A	N/A	Flare Type RT	N/A
N/A	Flare Slope LT (%)	N/A	N/A	Flare Slope RT (%)	N/A
N/A	Flare Traversable LT?	N/A	N/A	Flare Traversable RT?	N/A
N/A	Landing Length (in)	N/A	N/A	DWS Provided?	N/A
N/A	Landing Width (in)	N/A	N/A	DWS Contrast?	N/A
N/A	Landing Slope (%)	N/A	N/A	DWS Length (in)	N/A
N/A	Landing X Slope (%)	N/A	N/A	DWS Full Width?	N/A
N/A	Landing Curb? (Y/N)	N/A	N/A	DWS Offset (in)	N/A
N/A	Shared Landing?	N/A			
N/A	Gutter Ponding?	N/A	N/A	Gutter Slope (%)	N/A
N/A	Gutter Lip Ht (in)	N/A	N/A	Gutter X Slope (%)	N/A
N/A	Painted X Walk1?	No	N/A	Painted X Walk2?	N/A
	X Walk 1 Direction	To S		X Walk 2 Direction	N/A
N/A	X Walk 1 Width (in)	N/A	N/A	X Walk 2 Width (in)	N/A
	X Walk 1 Slope (%)	1.9		X Walk 2 Slope (%)	N/A
	X Walk 1 X Slope (%)	5.0		X Walk 2 X Slope (%)	N/A

N/A	Ramp inside XWalk1?	N/A	N/A	Ramp inside XWalk2?	N/A
	Road Slope (%)	N/A	N/A	Clear Space?	N/A
	Road X Slope (%)	N/A	N/A	Clear Space to XWalk (in)	N/A
N/A	Any Obstructions?	N/A	N/A	Storm Grate/Utility Hazard?	N/A
	Obstruction Type			Storm Grate/Utility Type	
		N/A			N/A
			Yes	Surface Condition? (G/P)	Good

Remove & Replace Entire Ramp.

\$ 1850.00
