Access Compliance Report

Public Rights-of-Way

(Curb Ramps)

Intersection ID: 50517	Main Street: STEWART TERRACE WY	Cross Street: MICHAEL CROSSING DR	Location: W
ADA ID: 845DEDBA3D96	Ramp Type: PerpDiag	Initial Pass/Fail: Fail	Overall Compliance: No
Severity Score: 13.75			
Codes/Mitigation Info/Possible Solution		Field Measurements/Component Compliance

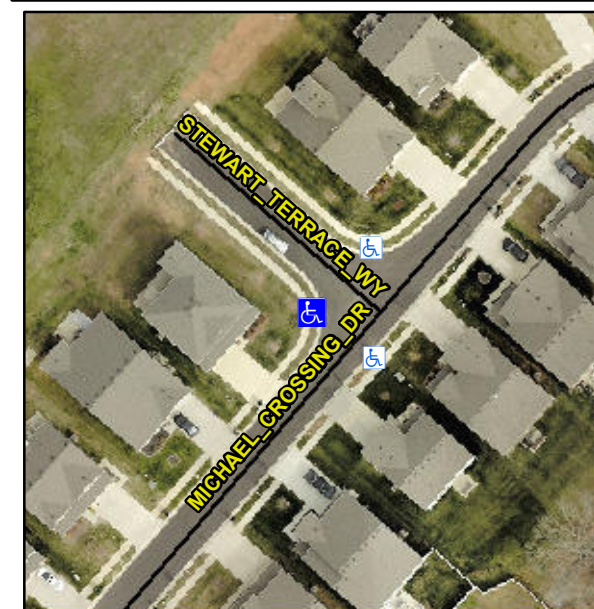
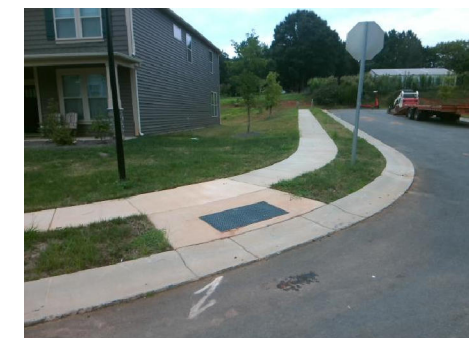
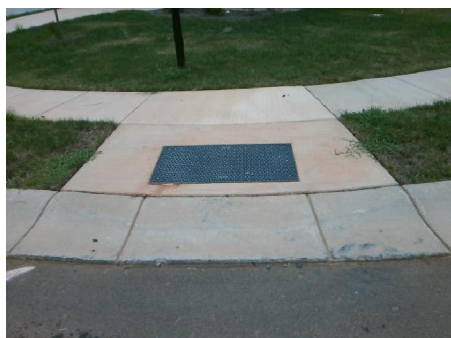
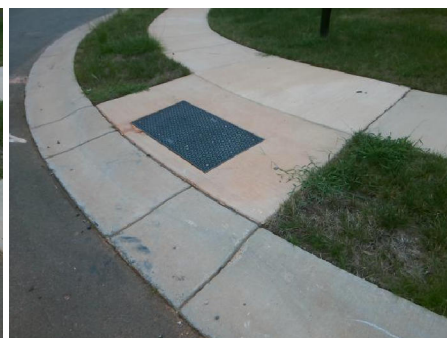
Not Found, R304.2.2, R304.5.3

Compliance	Description	Data	Compliance	Description	Data
N/A	Ramp Length (in)	48.0	No	Ramp Slope (%)	10.0
Yes	Ramp Width (in)	48.0	No	Ramp XSlope (%)	3.4
N/A	Flare Type LT	N/A	N/A	Flare Type RT	N/A
N/A	Flare Slope LT (%)	N/A	N/A	Flare Slope RT (%)	N/A
N/A	Flare Traversable LT?	N/A	N/A	Flare Traversable RT?	N/A
N/A	Landing Length (in)	N/A	N/A	DWS Provided?	N/A
N/A	Landing Width (in)	N/A	N/A	DWS Contrast?	N/A
N/A	Landing Slope (%)	N/A	N/A	DWS Length (in)	N/A
N/A	Landing X Slope (%)	N/A	N/A	DWS Full Width?	N/A
N/A	Landing Curb? (Y/N)	N/A	N/A	DWS Offset (in)	N/A
N/A	Shared Landing?	N/A			
N/A	Gutter Ponding?	N/A	N/A	Gutter Slope (%)	N/A
N/A	Gutter Lip Ht (in)	1.5	N/A	Gutter X Slope (%)	N/A
N/A	Painted X Walk1?	No	N/A	Painted X Walk2?	No
	X Walk 1 Direction	To SE		X Walk 2 Direction	To NE
N/A	X Walk 1 Width (in)	N/A	N/A	X Walk 2 Width (in)	N/A
	X Walk 1 Slope (%)	1.5		X Walk 2 Slope (%)	0.2
	X Walk 1 X Slope (%)	1.8		X Walk 2 X Slope (%)	2.9

N/A	Ramp inside XWalk1?	N/A	N/A	Ramp inside XWalk2?	N/A
	Road Slope (%)	3.1	N/A	Clear Space?	N/A
	Road X Slope (%)	0.7	N/A	Clear Space to XWalk (in)	N/A
N/A	Any Obstructions?	N/A	N/A	Storm Grate/Utility Hazard?	N/A
	Obstruction Type			Storm Grate/Utility Type	
		N/A			N/A
		Yes		Surface Condition? (G/P)	Good

Possible Solutions:

Remove & Replace Curb Ramp With Two New Directional Ramps or Equivalent.
