# Access Compliance Report

## Public Rights-of-Way

### (Curb Ramps)

Intersection ID: 32032	Main Street: COLONY_RD	Cross Street: WAKEHURST_RD	Location: NW
ADA ID: 846660CFD918	Ramp Type: PerpDiag	Initial Pass/Fail: Fail	Overall Compliance: No
		Severity Score: 22.5

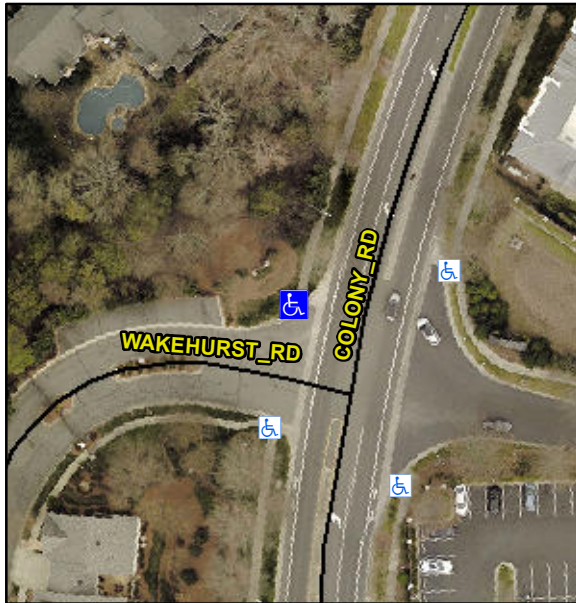
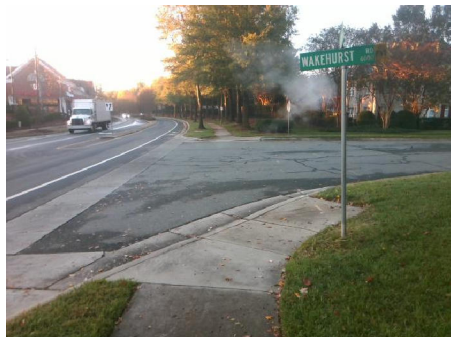
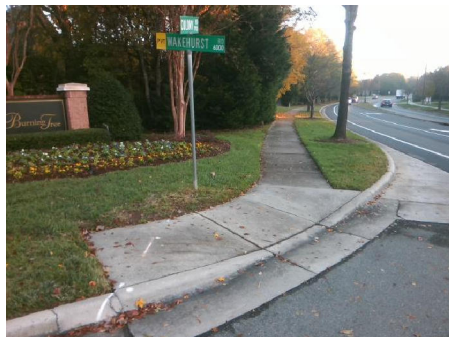
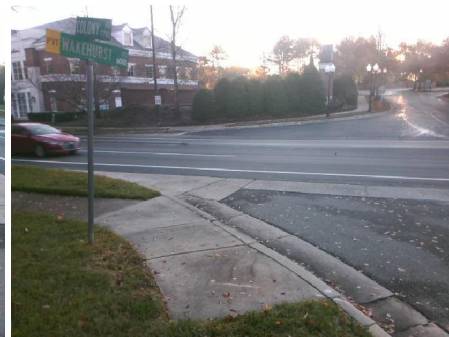
**Not Found, R304.5.1, R304.2.2, R304.5.3**

Compliance	Description	Data	Compliance	Description	Data
N/A	Ramp Length (in)	57.0	No	Ramp Slope (%)	9.3
No	Ramp Width (in)	42.0	No	Ramp XSlope (%)	2.1
N/A	Flare Type LT	N/A	N/A	Flare Type RT	N/A
N/A	Flare Slope LT (%)	N/A	N/A	Flare Slope RT (%)	N/A
N/A	Flare Traversable LT?	N/A	N/A	Flare Traversable RT?	N/A
N/A	Landing Length (in)	N/A	N/A	DWS Provided?	N/A
N/A	Landing Width (in)	N/A	N/A	DWS Contrast?	N/A
N/A	Landing Slope (%)	N/A	N/A	DWS Length (in)	N/A
N/A	Landing X Slope (%)	N/A	N/A	DWS Full Width?	N/A
N/A	Landing Curb? (Y/N)	N/A	N/A	DWS Offset (in)	N/A
N/A	Shared Landing?	N/A			
N/A	Gutter Ponding?	N/A	N/A	Gutter Slope (%)	N/A
N/A	Gutter Lip Ht (in)	N/A	N/A	Gutter X Slope (%)	N/A
N/A	Painted X Walk1?	No	N/A	Painted X Walk2?	No
	X Walk 1 Direction	To SW		X Walk 2 Direction	To E
N/A	X Walk 1 Width (in)	N/A	N/A	X Walk 2 Width (in)	N/A
	X Walk 1 Slope (%)	0.1		X Walk 2 Slope (%)	4.1
	X Walk 1 X Slope (%)	4.2		X Walk 2 X Slope (%)	0.5

N/A	Ramp inside XWalk1?	N/A	N/A	Ramp inside XWalk2?	N/A
	Road Slope (%)	3.5	N/A	Clear Space?	N/A
	Road X Slope (%)	3.0	N/A	Clear Space to XWalk (in)	N/A
N/A	Any Obstructions?	N/A	N/A	Storm Grate/Utility Hazard?	N/A
	Obstruction Type			Storm Grate/Utility Type	
		N/A			N/A
			Yes	Surface Condition? (G/P)	Good

**Remove & Replace Curb Ramp With Two New Directional Ramps or Equivalent.**
