Access Compliance Report

Public Rights-of-Way

| Intersection ID: 29736 | Main Street: BALLANTYNE CORPORATE PCross Street: HARNEY DR | Location: NW |
| ADA ID: 8471C6E39576 | Ramp Type: BlendTrans2 | Initial Pass/Fail: Pass Overall Compliance: No Severity Score: 15.25 |

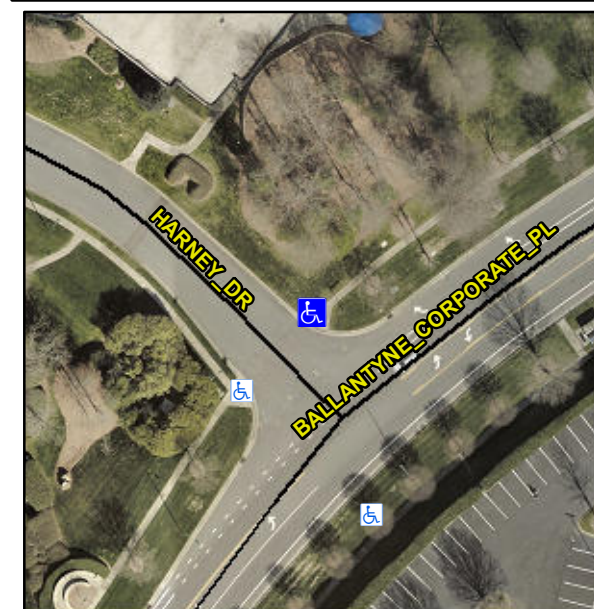
| Compliance | Description | Data | Compliance | Description | Data |
|---|---|---|---|---|---|
| N/A | Ramp Length (in) | 136.0 | Yes | BlendTrans Slope (%) | 4.4 |
| Yes | Ramp Width (in) | 48.0 | No | BlendTrans XSlope (%) | 3.2 |
| N/A | Landing Length (in) | N/A | No | DWS Provided? | No |
| Yes | Gutter Ponding? | No | No | Gutter Slope (%) | 5.8 |

Possible Solutions:

Remove & Replace Curb Ramp With Two New Directional Ramps or Equivalent. Remove & Replace Gutter.

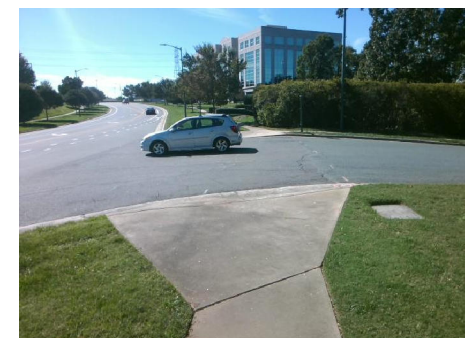
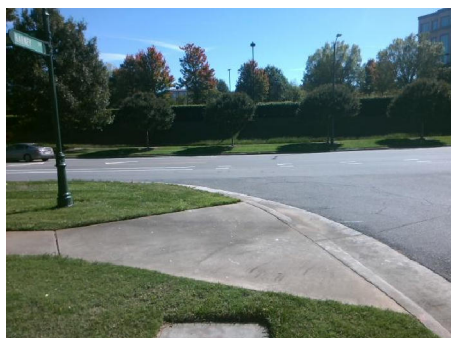
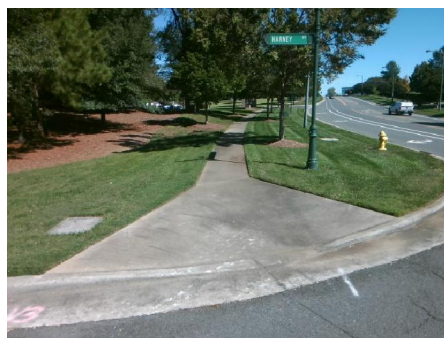
Street 1 Name HARNEY DR
 Stop Condition-Street 1 StopSign
 Street 2 Name BALLANTYNE CORPORATE PL
 Stop Condition-Street 2 None
