# Access Compliance Report

## Public Rights-of-Way (Curb Ramps)

Intersection ID: 49257	Main Street: BERRYBROOK_LN	Cross Street: SINGING_OAK_CT	Location: S
ADA ID: 8478717EFC4C	Ramp Type: PerpDiag	Initial Pass/Fail: Fail	Overall Compliance: No Severity Score: 26.25

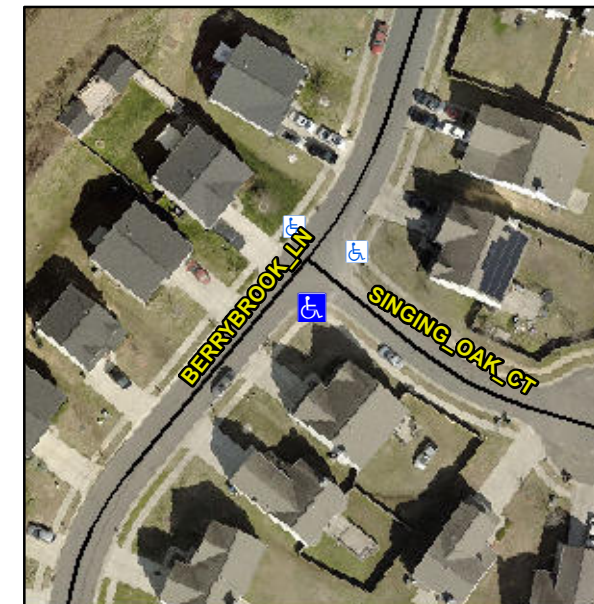
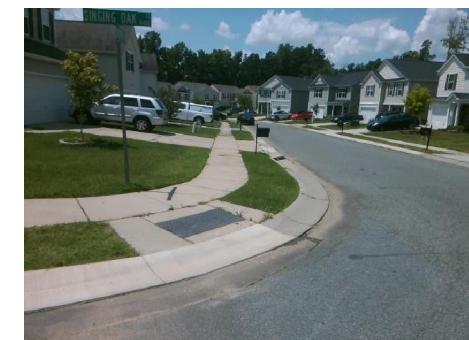
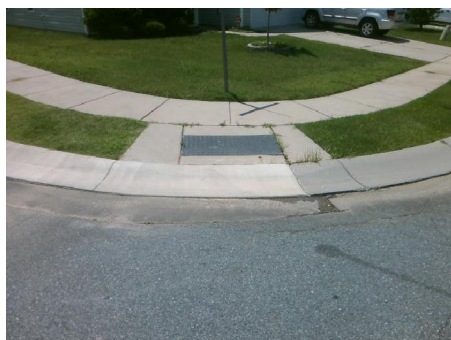
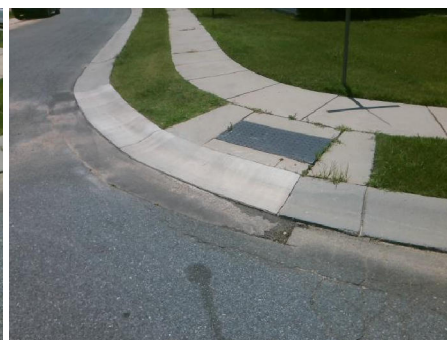
**Not Found, R304.2.2, R304.5.3**

Compliance	Description	Data	Compliance	Description	Data
N/A	Ramp Length (in)	47.0	No	Ramp Slope (%)	20.0
Yes	Ramp Width (in)	48.0	No	Ramp XSlope (%)	3.1
N/A	Flare Type LT	N/A	N/A	Flare Type RT	N/A
N/A	Flare Slope LT (%)	N/A	N/A	Flare Slope RT (%)	N/A
N/A	Flare Traversable LT?	N/A	N/A	Flare Traversable RT?	N/A
N/A	Landing Length (in)	N/A	N/A	DWS Provided?	N/A
N/A	Landing Width (in)	N/A	N/A	DWS Contrast?	N/A
N/A	Landing Slope (%)	N/A	N/A	DWS Length (in)	N/A
N/A	Landing X Slope (%)	N/A	N/A	DWS Full Width?	N/A
N/A	Landing Curb? (Y/N)	N/A	N/A	DWS Offset (in)	N/A
N/A	Shared Landing?	N/A			
N/A	Gutter Ponding?	N/A	N/A	Gutter Slope (%)	N/A
N/A	Gutter Lip Ht (in)	N/A	N/A	Gutter X Slope (%)	N/A
N/A	Painted X Walk1?	No	N/A	Painted X Walk2?	No
	X Walk 1 Direction	To NE		X Walk 2 Direction	To NW
N/A	X Walk 1 Width (in)	N/A	N/A	X Walk 2 Width (in)	N/A
	X Walk 1 Slope (%)	4.0		X Walk 2 Slope (%)	3.3
	X Walk 1 X Slope (%)	0.1		X Walk 2 X Slope (%)	5.6

N/A	Ramp inside XWalk1?	N/A	N/A	Ramp inside XWalk2?	N/A
	Road Slope (%)	3.7	N/A	Clear Space?	N/A
	Road X Slope (%)	6.3	N/A	Clear Space to XWalk (in)	N/A
N/A	Any Obstructions?	N/A	N/A	Storm Grate/Utility Hazard?	N/A
	Obstruction Type			Storm Grate/Utility Type	
		N/A			N/A
			Yes	Surface Condition? (G/P)	Good

**Remove & Replace Curb Ramp With Two New Directional Ramps or Equivalent.**
