# Access Compliance Report

## Public Rights-of-Way

### (Curb Ramps)

Intersection ID: 49312	Main Street: MISTY_EVE_LN	Cross Street: BROOKE_NICOLE_PL	Location: S
ADA ID: 8479F82F5FC2	Ramp Type: PerpDiag	Initial Pass/Fail: Fail	Overall Compliance: No
Severity Score: 13.75			
Codes/Mitigation Info/Possible Solution		Field Measurements/Component Compliance

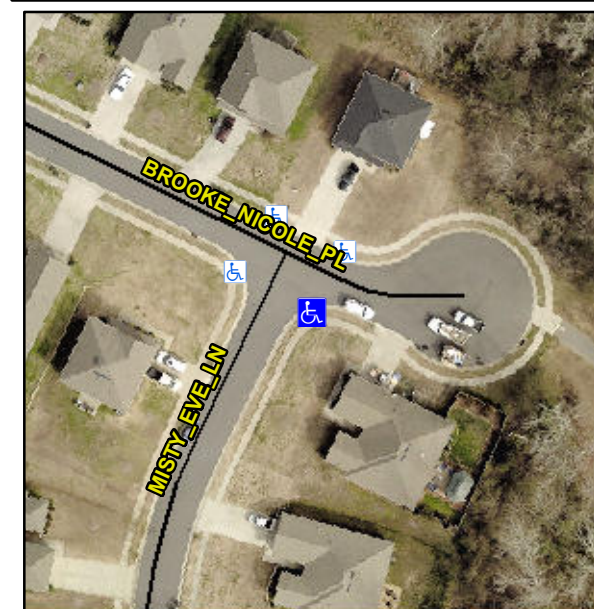
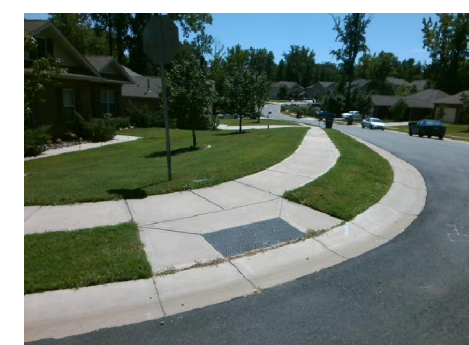
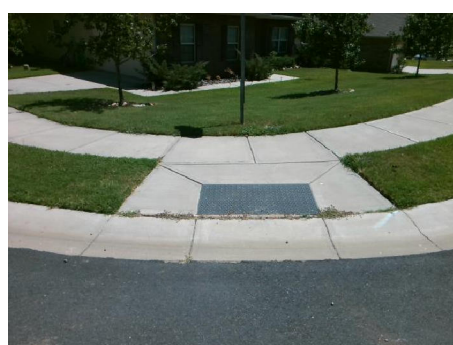
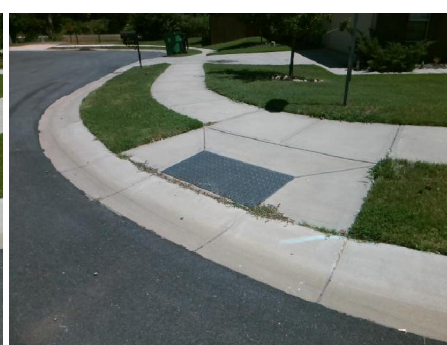
**Not Found, R304.2.2, R304.5.3**

Compliance	Description	Data	Compliance	Description	Data
N/A	Ramp Length (in)	48.0	No	Ramp Slope (%)	9.8
Yes	Ramp Width (in)	48.0	No	Ramp XSlope (%)	4.5
N/A	Flare Type LT	N/A	N/A	Flare Type RT	N/A
N/A	Flare Slope LT (%)	N/A	N/A	Flare Slope RT (%)	N/A
N/A	Flare Traversable LT?	N/A	N/A	Flare Traversable RT?	N/A
N/A	Landing Length (in)	N/A	N/A	DWS Provided?	N/A
N/A	Landing Width (in)	N/A	N/A	DWS Contrast?	N/A
N/A	Landing Slope (%)	N/A	N/A	DWS Length (in)	N/A
N/A	Landing X Slope (%)	N/A	N/A	DWS Full Width?	N/A
N/A	Landing Curb? (Y/N)	N/A	N/A	DWS Offset (in)	N/A
N/A	Shared Landing?	N/A			
N/A	Gutter Ponding?	N/A	N/A	Gutter Slope (%)	N/A
N/A	Gutter Lip Ht (in)	N/A	N/A	Gutter X Slope (%)	N/A
N/A	Painted X Walk1?	No	N/A	Painted X Walk2?	No
	X Walk 1 Direction	To E		X Walk 2 Direction	To W
N/A	X Walk 1 Width (in)	N/A	N/A	X Walk 2 Width (in)	N/A
	X Walk 1 Slope (%)	8.8		X Walk 2 Slope (%)	12.1
	X Walk 1 X Slope (%)	10.3		X Walk 2 X Slope (%)	6.8

N/A	Ramp inside XWalk1?	N/A	N/A	Ramp inside XWalk2?	N/A
	Road Slope (%)	2.2	N/A	Clear Space?	N/A
	Road X Slope (%)	12.8	N/A	Clear Space to XWalk (in)	N/A
N/A	Any Obstructions?	N/A	N/A	Storm Grate/Utility Hazard?	N/A
	Obstruction Type			Storm Grate/Utility Type	
		N/A			N/A
			Yes	Surface Condition? (G/P)	Good

**Remove & Replace Curb Ramp With Two New Directional Ramps or Equivalent.**
