Access Compliance Report Public Rights-of-Way (Curb Ramps)

Intersection ID: 29184 Main Street: CHALKBARK_LN Cross Street: JADE_GLEN_DR Location: S

ADA ID: 848F082A9EF4 Ramp Type: PerpDiag Initial Pass/Fail: Fail Overall Compliance: No Severity Score: 22.5

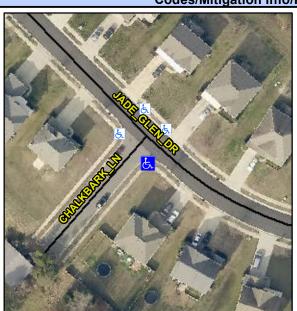
Not Found, R304.5.1, R304.2.2, R304.5.3

rield Measurements/Component Compilance							
	Comp	Compliance Description		Compliance Description		Data	
	N/A	Ramp Length (in)	49.0	No	Ramp Slope (%)	9.2	
	No	Ramp Width (in)	47.0	No	Ramp XSlope (%)	3.4	
	N/A	Flare Type LT	N/A	N/A	Flare Type RT	N/A	
	N/A	Flare Slope LT (%)	N/A	N/A	Flare Slope RT (%)	N/A	
	N/A	Flare Traversable LT?	N/A	N/A	Flare Traversable RT?	N/A	
	N/A	Landing Length (in)	N/A	N/A	DWS Provided?	N/A	
	N/A	Landing Width (in)	N/A	N/A	DWS Contrast?	N/A	
	N/A	Landing Slope (%)	N/A	N/A	DWS Length (in)	N/A	
	N/A	Landing X Slope (%)	N/A	N/A	DWS Full Width?	N/A	
	N/A	Landing Curb? (Y/N)	N/A	N/A	DWS Offset (in)	N/A	
	N/A	Shared Landing?	N/A				
	N/A	Gutter Ponding?	N/A	N/A	Gutter Slope (%)	N/A	
	N/A	Gutter Lip Ht (in)	N/A	N/A	Gutter X Slope (%)	N/A	
	N/A	Painted X Walk1?	No	N/A	Painted X Walk2?	No	
		X Walk 1 Direction	To NE		X Walk 2 Direction	To NW	
	N/A	X Walk 1 Width (in)	N/A	N/A	X Walk 2 Width (in)	N/A

X Walk 1 Slope (%)	1.2		X Walk 2 Slope (%)	2.7	
		X Walk 1 X Slope (%)	2.3		X Walk 2 X Slope (%)	0.8	
	N/A	Ramp inside XWalk1?	N/A	N/A	Ramp inside XWalk2?	N/A	
		Road Slope (%)	3.2	N/A	Clear Space?	N/A	
		Road X Slope (%)	2.5	N/A	Clear Space to XWalk (in)	N/A	
	N/A	Any Obstructions?	N/A	N/A	Storm Grate/Utility Hazard?	N/A	
		Obstruction Type			Storm Grate/Utility Type		
			N/A			N/A

JADE GLEN DR None CHALKBARK RD StopSign Possible Solutions:

Remove & Replace Curb Ramp With Two New Directional Ramps or Equivalent.

Total Cost: \$ 3200.00
