# Access Compliance Report

## Public Rights-of-Way

### (Curb Ramps)

Intersection ID: N/A	Main Street: GROVER_RD	Cross Street: N/A	Location: NW
ADA ID: 8492C50934EF	Ramp Type: PerpDiag	Initial Pass/Fail: Fail	Overall Compliance: No
		Severity Score: 12.5

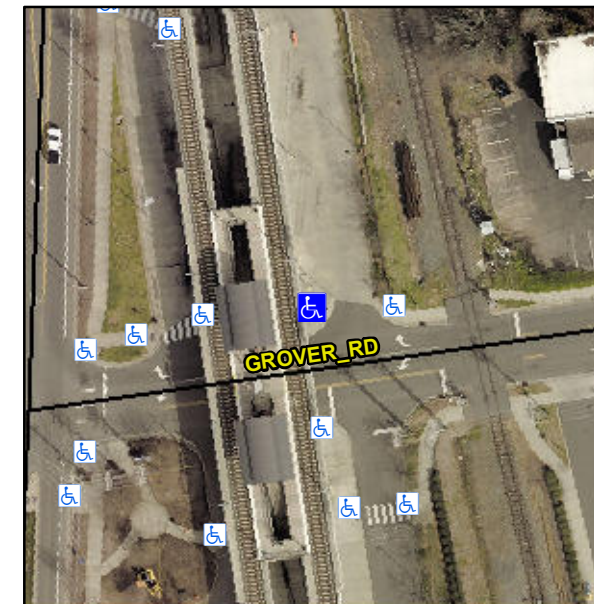
**Not Found, R304.2.2**

Compliance	Description	Data	Compliance	Description	Data
N/A	Ramp Length (in)	80.0	No	Ramp Slope (%)	11.6
Yes	Ramp Width (in)	48.0	Yes	Ramp XSlope (%)	1.5
N/A	Flare Type LT	N/A	N/A	Flare Type RT	N/A
N/A	Flare Slope LT (%)	N/A	N/A	Flare Slope RT (%)	N/A
N/A	Flare Traversable LT?	N/A	N/A	Flare Traversable RT?	N/A
N/A	Landing Length (in)	N/A	N/A	DWS Provided?	N/A
N/A	Landing Width (in)	N/A	N/A	DWS Contrast?	N/A
N/A	Landing Slope (%)	N/A	N/A	DWS Length (in)	N/A
N/A	Landing X Slope (%)	N/A	N/A	DWS Full Width?	N/A
N/A	Landing Curb? (Y/N)	N/A	N/A	DWS Offset (in)	N/A
N/A	Shared Landing?	N/A			
N/A	Gutter Ponding?	N/A	N/A	Gutter Slope (%)	N/A
N/A	Gutter Lip Ht (in)	N/A	N/A	Gutter X Slope (%)	N/A
N/A	Painted X Walk1?	No	N/A	Painted X Walk2?	No
	X Walk 1 Direction	To S		X Walk 2 Direction	To E
N/A	X Walk 1 Width (in)	N/A	N/A	X Walk 2 Width (in)	N/A
	X Walk 1 Slope (%)	1.2		X Walk 2 Slope (%)	4.5
	X Walk 1 X Slope (%)	3.8		X Walk 2 X Slope (%)	0.4

**Remove & Replace Curb Ramp With Two New Directional Ramps or Equivalent.**

Total Cost: \$ 3200.00

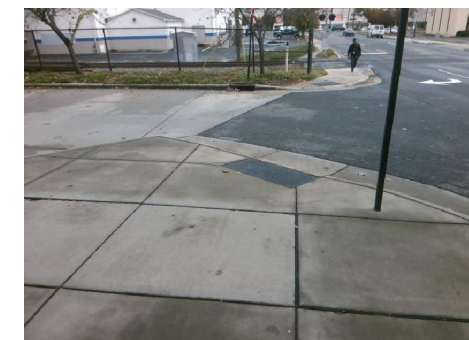
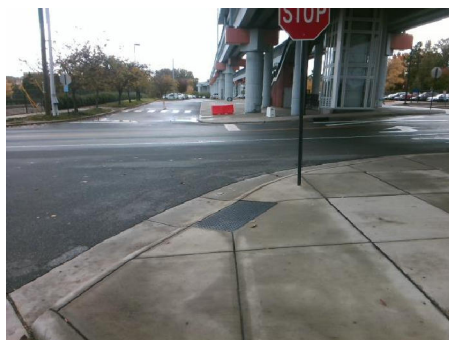
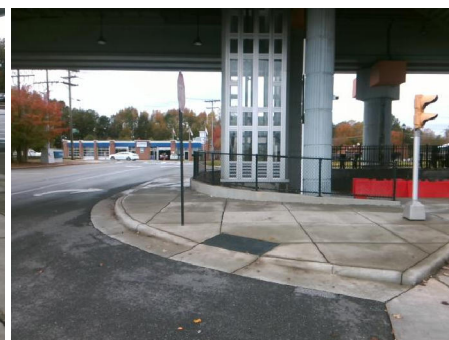
N/A	Ramp inside XWalk1?	N/A	N/A	Ramp inside XWalk2?	N/A
	Road Slope (%)	1.5	N/A	Clear Space?	N/A
	Road X Slope (%)	3.5	N/A	Clear Space to XWalk (in)	N/A
N/A	Any Obstructions?	N/A	N/A	Storm Grate/Utility Hazard?	N/A
	Obstruction Type			Storm Grate/Utility Type	
		N/A			N/A
			Yes	Surface Condition? (G/P)	Good
