# Access Compliance Report

## Public Rights-of-Way

### (Curb Ramps)

| Intersection ID: 15351 | Main Street: CLANTON_RD | Cross Street: BARRINGER_DR | Location: NW |

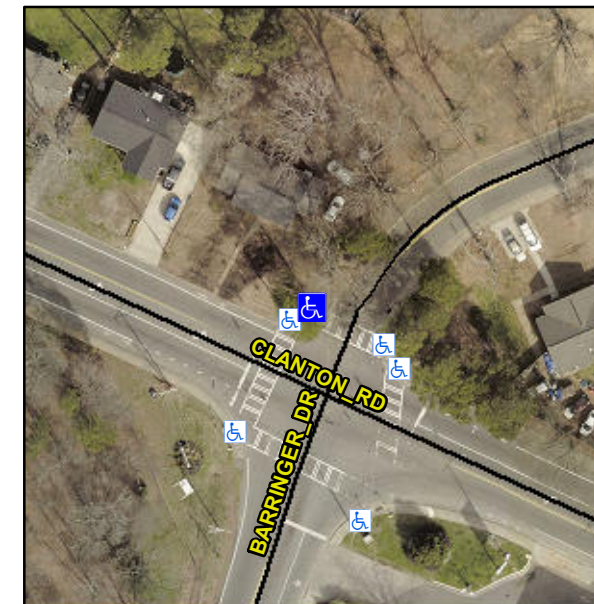
**Not Found, R304.2.3, R305.2, R304.5.4**

| Compliance | Description | Data | Compliance | Description | Data |
|---|---|---|---|---|---|
| No | Flare Slope LT (%) | N/A | N/A | Flare Slope RT (%) | N/A |
| N/A | Landing Curb? (Y/N) | No | No | DWS Offset (in) | 6.0 |
| Yes | Gutter Ponding? | No | No | Gutter Slope (%) | 5.8 |
| | | | No | Curb Slope (%) | 15.0 |

**Remove & Replace Curb Ramp With Two New Directional Ramps or Equivalent. Remove & Replace Gutter.**
