Access Compliance Report

Public Rights-of-Way

(Curb Ramps)

Intersection ID: 48580	Main Street: SWEET_FLAG_CT	Cross Street: RUMPLE_RD	Location: SE
ADA ID: 84A9ECE09D4F	Ramp Type: Perp	Initial Pass/Fail: Fail	Overall Compliance: No
Severity Score: 12.5			
Codes/Mitigation Info/Possible Solution		Field Measurements/Component Compliance

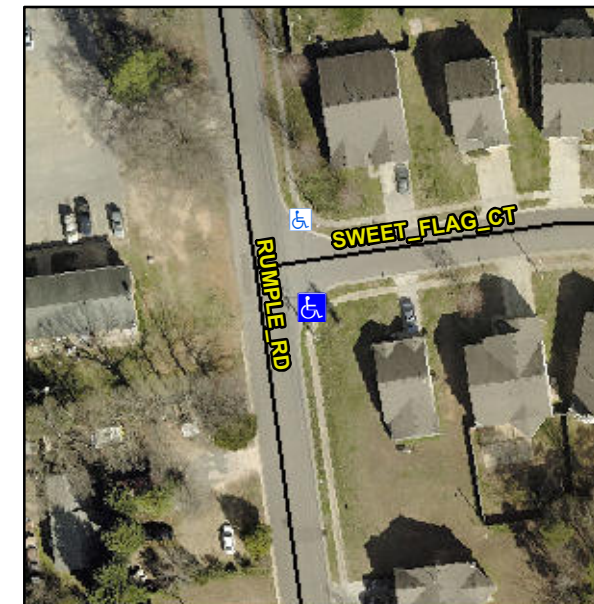
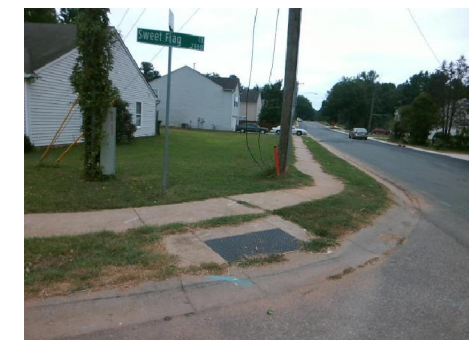
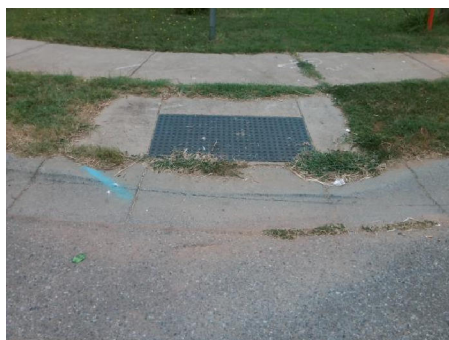
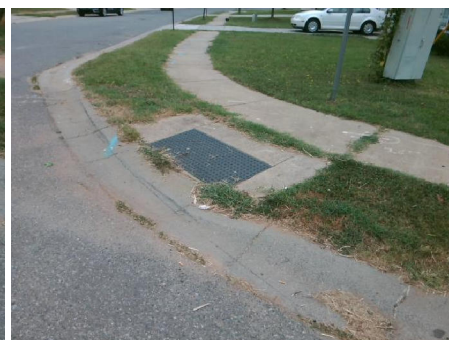
Not Found, R304.2.2

Compliance	Description	Data	Compliance	Description	Data
N/A	Ramp Length (in)	46.0	No	Ramp Slope (%)	8.4
Yes	Ramp Width (in)	48.5	Yes	Ramp XSlope (%)	0.3
N/A	Flare Type LT	N/A	N/A	Flare Type RT	N/A
N/A	Flare Slope LT (%)	N/A	N/A	Flare Slope RT (%)	N/A
N/A	Flare Traversable LT?	N/A	N/A	Flare Traversable RT?	N/A
N/A	Landing Length (in)	N/A	N/A	DWS Provided?	N/A
N/A	Landing Width (in)	N/A	N/A	DWS Contrast?	N/A
N/A	Landing Slope (%)	N/A	N/A	DWS Length (in)	N/A
N/A	Landing X Slope (%)	N/A	N/A	DWS Full Width?	N/A
N/A	Landing Curb? (Y/N)	N/A	N/A	DWS Offset (in)	N/A
N/A	Shared Landing?	N/A			
N/A	Gutter Ponding?	N/A	N/A	Gutter Slope (%)	N/A
N/A	Gutter Lip Ht (in)	N/A	N/A	Gutter X Slope (%)	N/A
N/A	Painted X Walk1?	No	N/A	Painted X Walk2?	N/A
	X Walk 1 Direction	To N		X Walk 2 Direction	N/A
N/A	X Walk 1 Width (in)	N/A	N/A	X Walk 2 Width (in)	N/A
	X Walk 1 Slope (%)	1.7		X Walk 2 Slope (%)	N/A
	X Walk 1 X Slope (%)	0.1		X Walk 2 X Slope (%)	N/A

N/A	Ramp inside XWalk1?	N/A	N/A	Ramp inside XWalk2?	N/A
	Road Slope (%)	N/A	N/A	Clear Space?	N/A
	Road X Slope (%)	N/A	N/A	Clear Space to XWalk (in)	N/A
N/A	Any Obstructions?	N/A	N/A	Storm Grate/Utility Hazard?	N/A
	Obstruction Type			Storm Grate/Utility Type	
		N/A			N/A
		Yes		Surface Condition? (G/P)	Good

Remove & Replace Entire Ramp.

Total Cost: \$ 1850.00
