Access Compliance Report

Public Rights-of-Way

(Curb Ramps)

Intersection ID: 53270	Main Street: MONROE_RD	Cross Street: MERIDIAN_CENTER_DR	Location: NE
ADA ID: 84AA31CECF00	Ramp Type: Directional1	Initial Pass/Fail: Pass	Overall Compliance: No
		Severity Score: 10

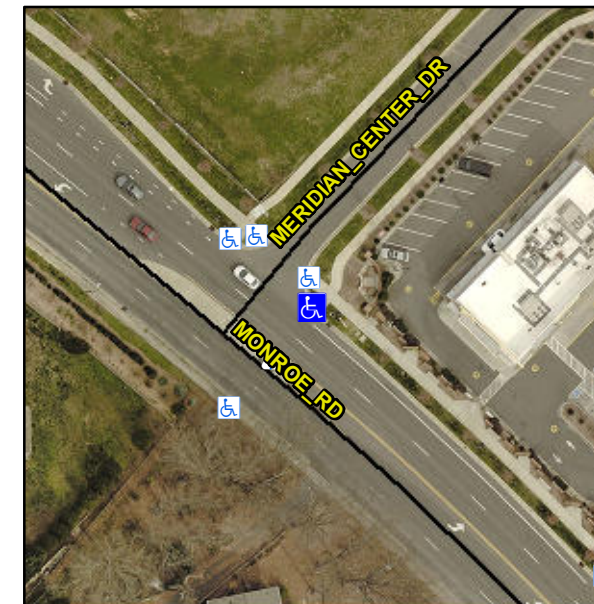
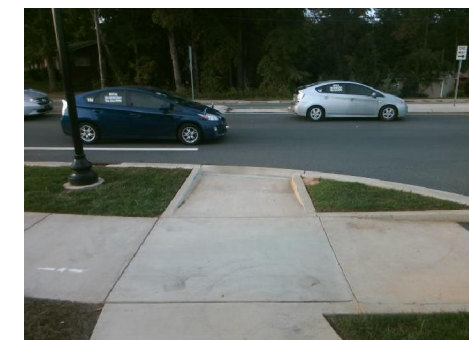
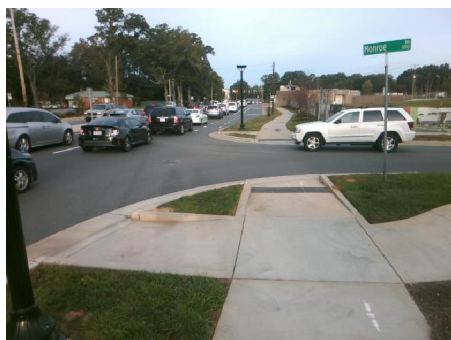
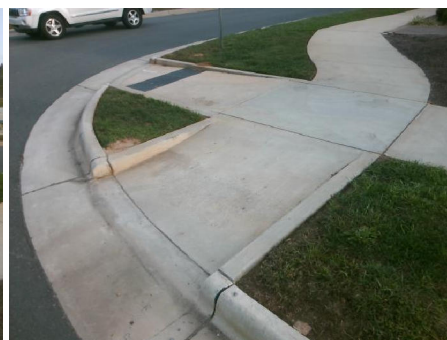
Compliance	Description	Data	Compliance	Description	Data
N/A	Ramp Length (in)	71.0	No	Grade Break?	No
Yes	Ramp Width (in)	69.0	N/A	Grade Break Slope (%)	1.4
Yes	Ramp Slope (%)	5.2	N/A	Grade Break XSlope (%)	1.6
Yes	Ramp XSlope (%)	0.4			
Yes	Flare Type LT	N/A	Yes	Flare Type RT	N/A
N/A	Flare Slope LT (%)	N/A	N/A	Flare Slope RT (%)	N/A
N/A	Flare Traversable LT?	No	N/A	Flare Traversable RT?	No
Yes	Landing Length (in)	70.0	No	DWS Provided?	No
Yes	Landing Width (in)	69.0	N/A	DWS Contrast?	No
Yes	Landing Slope (%)	1.2	N/A	DWS Length (in)	N/A
Yes	Landing X Slope (%)	0.9	N/A	DWS Full Width?	No
N/A	Landing Curb? (Y/N)	N/A	N/A	DWS Offset LT (in)	N/A
N/A	Shared Landing?	Yes	N/A	DWS Offset RT (in)	N/A
Yes	Gutter Ponding?	No	Yes	Gutter Slope (%)	3.7
Yes	Gutter Lip Ht (in)	0.0	Yes	Gutter X Slope (%)	1.0
N/A	Painted X Walk1?	No		Road Slope (%)	2.1
	X Walk 1 Direction	To SW		Road X Slope (%)	1.4
	X Walk 1 Width (in)	N/A		Clear Space?	Yes

X Walk 1 Slope (%)	2.1	N/A	Clear Space to XWalk (in)	N/A
	X Walk 1 X Slope (%)	1.4	Yes	Storm Grate/Utility Hazard?	No
N/A	Ramp inside XWalk1?	N/A		Storm Grate/Utility Type	
Yes	Any Obstructions?	No			N/A
	Obstruction Type		Yes	Surface Condition? (G/P)	Good
			N/A	Curb Slope (%)	6.0

Remove & Replace Entire Ramp.

R304.5.2, R305
