# Access Compliance Report

## Public Rights-of-Way

### (Curb Ramps)

Intersection ID: 11615	Main Street: E_18TH_ST	Cross Street: N_ALEXANDER_ST	Location: W
ADA ID: 84AE4A8CC342	Ramp Type: PerpDiag	Initial Pass/Fail: Fail	Overall Compliance: No
		Severity Score: 55

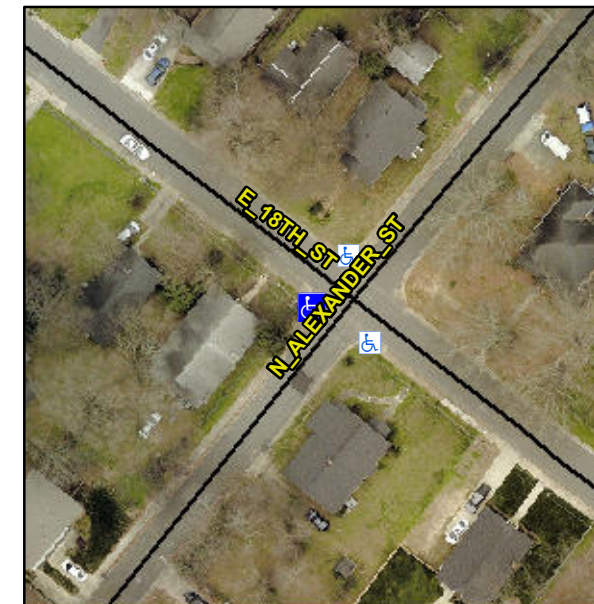
Compliance	Description	Data	Compliance	Description	Data
N/A	Ramp Length (in)	48.0	No	Ramp Slope (%)	12.3
No	Ramp Width (in)	32.0	No	Ramp XSlope (%)	5.6
N/A	Flare Type LT	N/A	N/A	Flare Type RT	N/A
N/A	Flare Slope LT (%)	N/A	N/A	Flare Slope RT (%)	N/A
N/A	Flare Traversable LT?	N/A	N/A	Flare Traversable RT?	N/A
N/A	Landing Length (in)	N/A	N/A	DWS Provided?	N/A
N/A	Landing Width (in)	N/A	N/A	DWS Contrast?	N/A
N/A	Landing Slope (%)	N/A	N/A	DWS Length (in)	N/A
N/A	Landing X Slope (%)	N/A	N/A	DWS Full Width?	N/A
N/A	Landing Curb? (Y/N)	N/A	N/A	DWS Offset (in)	N/A
N/A	Shared Landing?	N/A			
N/A	Gutter Ponding?	N/A	N/A	Gutter Slope (%)	N/A
N/A	Gutter Lip Ht (in)	N/A	N/A	Gutter X Slope (%)	N/A
N/A	Painted X Walk1?	No	N/A	Painted X Walk2?	No
	X Walk 1 Direction	To SE		X Walk 2 Direction	To NE
N/A	X Walk 1 Width (in)	N/A	N/A	X Walk 2 Width (in)	N/A
	X Walk 1 Slope (%)	3.6		X Walk 2 Slope (%)	1.9
	X Walk 1 X Slope (%)	9.1		X Walk 2 X Slope (%)	2.8

N/A	Ramp inside XWalk1?	N/A	N/A	Ramp inside XWalk2?	N/A
	Road Slope (%)	2.0	N/A	Clear Space?	N/A
	Road X Slope (%)	0.2	N/A	Clear Space to XWalk (in)	N/A
N/A	Any Obstructions?	N/A	N/A	Storm Grate/Utility Hazard?	N/A
	Obstruction Type			Storm Grate/Utility Type	
		N/A			N/A
			Yes	Surface Condition? (G/P)	Good

**Remove & Replace Curb Ramp With Two New Directional Ramps or Equivalent.**

**R304.5.1, R304.2.2, R304.5.3**
